Park Tower Condominium Association

June 19, 2024 • Chicago, IL

Park Tower Condominium Association
Chicago, Illinois

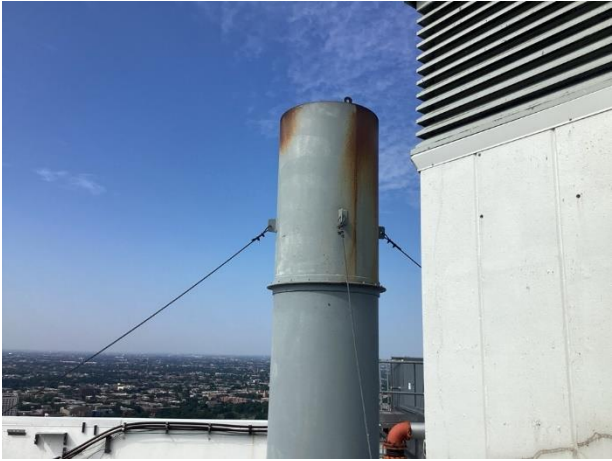
Boiler stack rust

- Asphalt Pavement, Crack Repair, Patch and Seal Coat Applications
- Boiler Stack (The stack exhibits areas of rust. We assume timely paint applications and repairs to defer total replacement.)

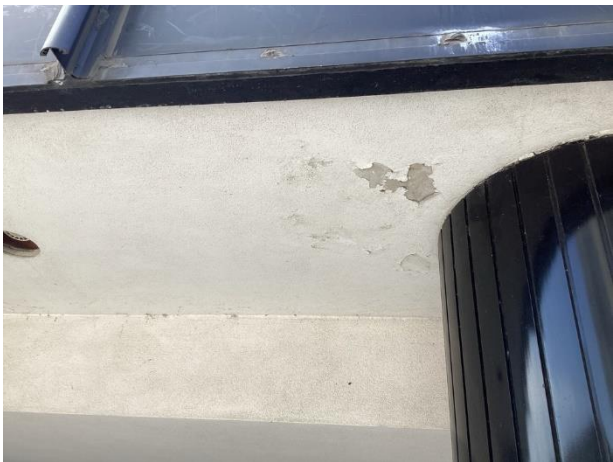
Soffit finish damage

• Snow Removal Equipment (Except Tractor)
• Soffits (Paint finishes and repairs through the operating budget per Management) (The soffits exhibit areas of significant finish deterioration.)

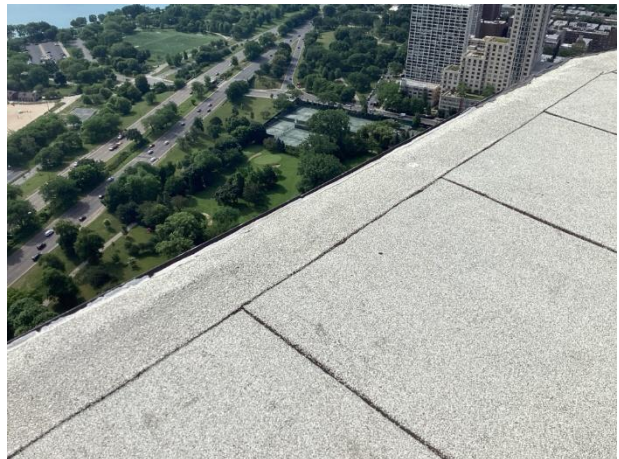
- **Tower, Main and Mechanical Penthouse** – 10,300 square feet of modified bitumen roofing, replaced 2017, good to fair overall with areas of perimeter sealant deterioration, depressions, granular loss and previous repairs evident
- **Lobby Canopy** – 800 square feet of flat membrane roofing, replaced 2012

Perimeter sealant deterioration at tower roof

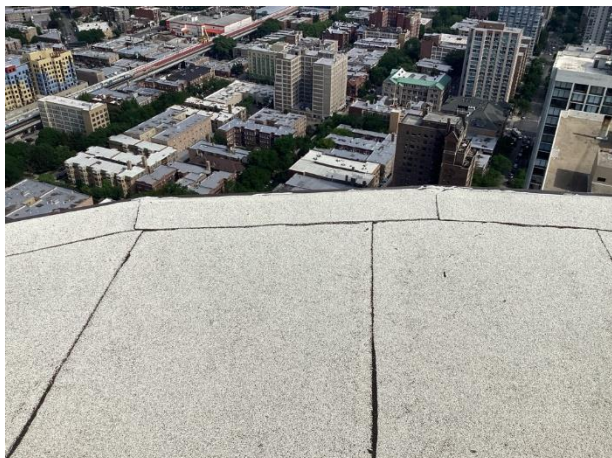
Perimeter sealant deterioration at tower roof

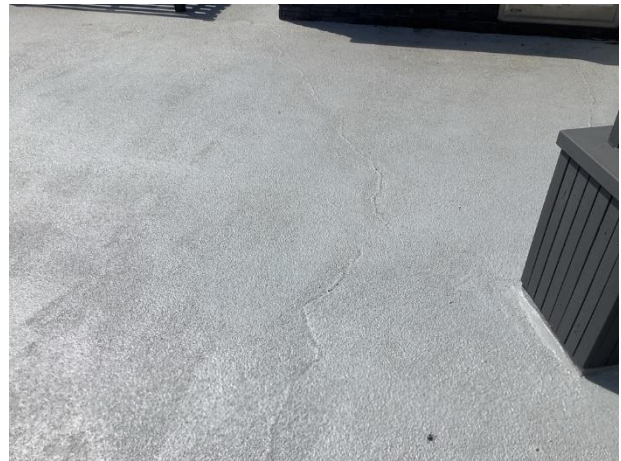
Concrete repairs beneath traffic coating at 2nd floor roof

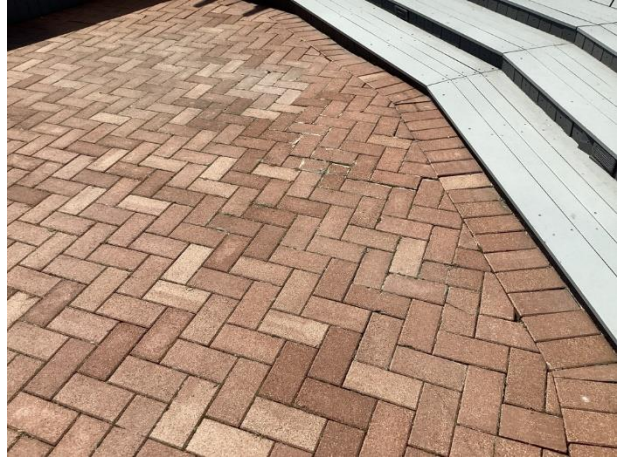
Paver settlement and cracks at 2nd floor roof

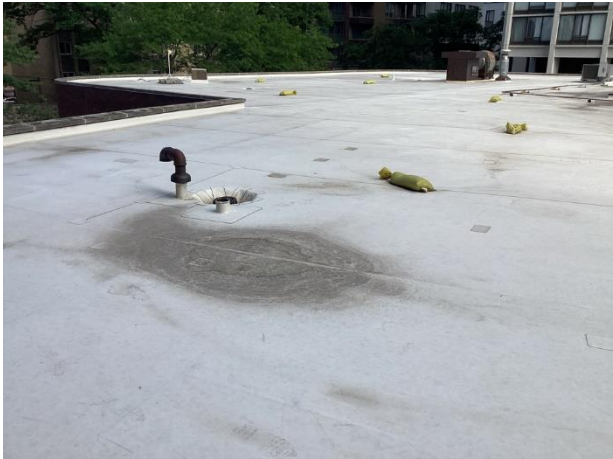
Northwest 2nd floor roof at depression

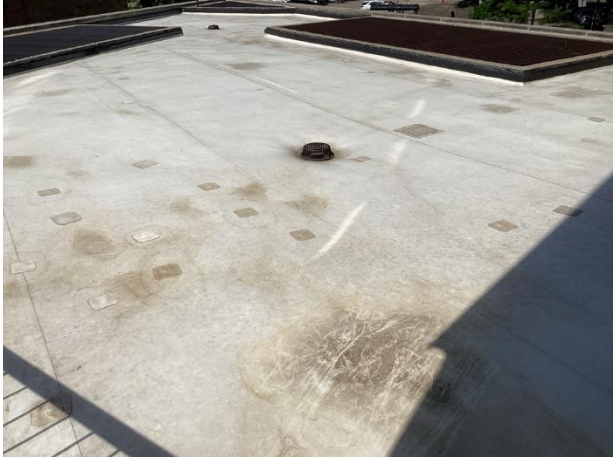
Southwest 2nd floor roof system at repairs

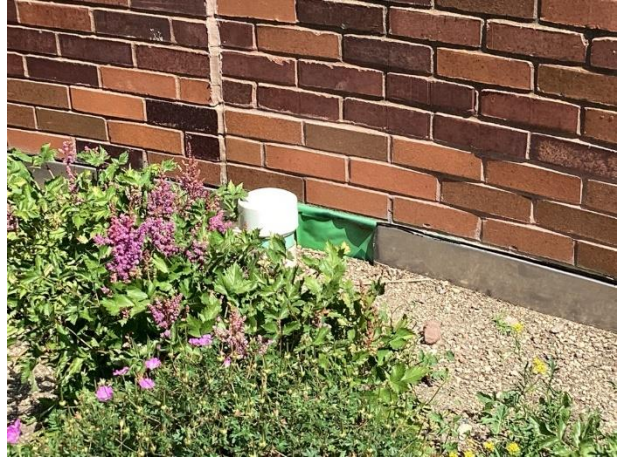
Flashing repairs at 2nd floor planter

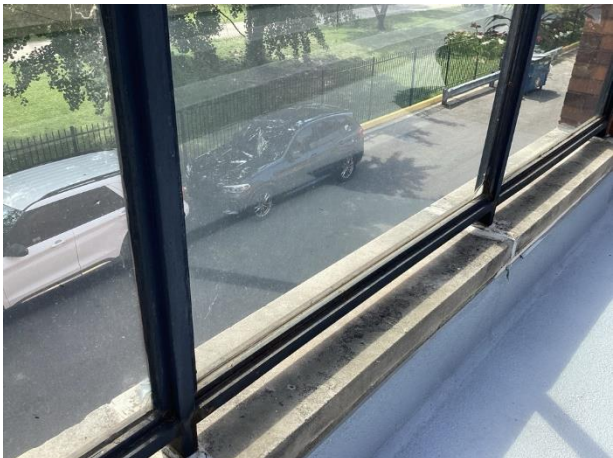
Glass damage at steel corrosion at 2nd floor east railing

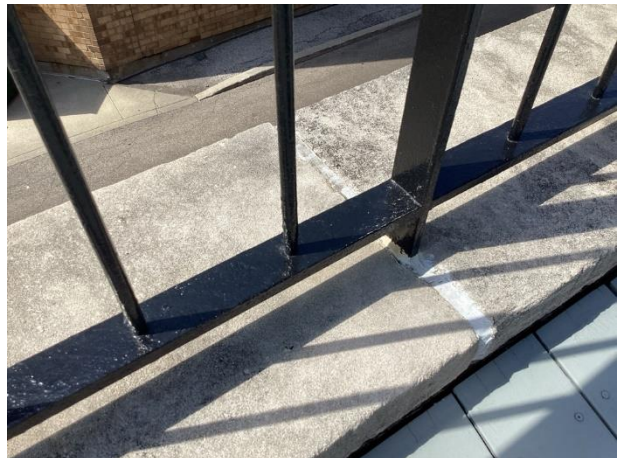
Rust at inset post at 2nd floor railing

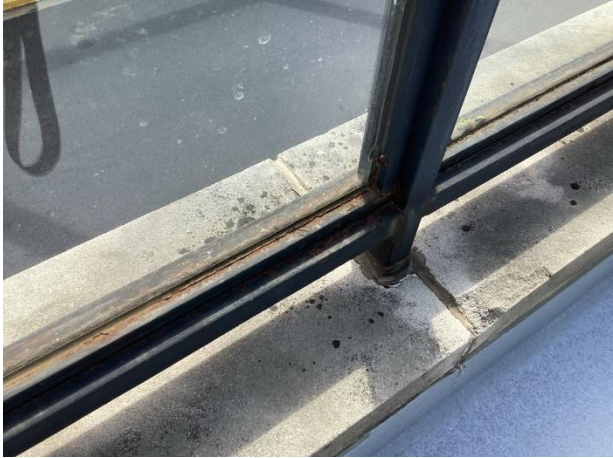
Steel corrosion and inset post at 2nd floor east perimeter

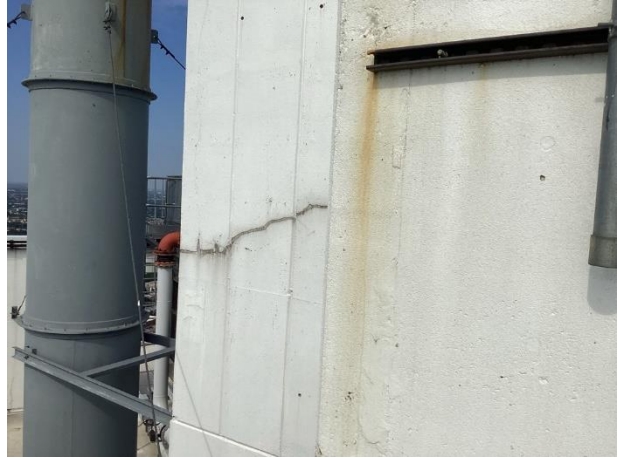
Cracks at penthouse structure

Useful Life: We recommend concrete inspections, coating applications and repairs up to every 12 years.

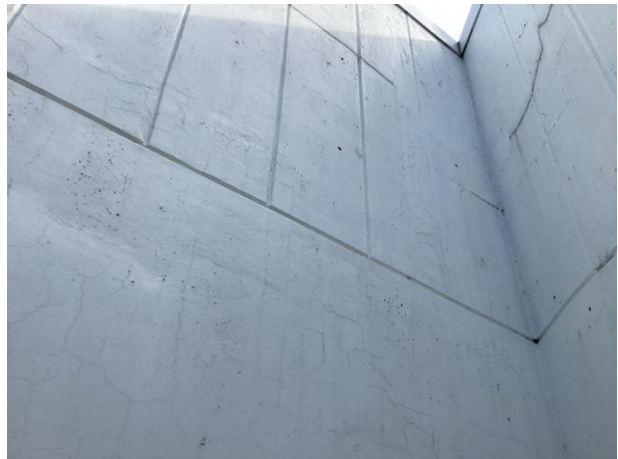
Cracks at penthouse structure

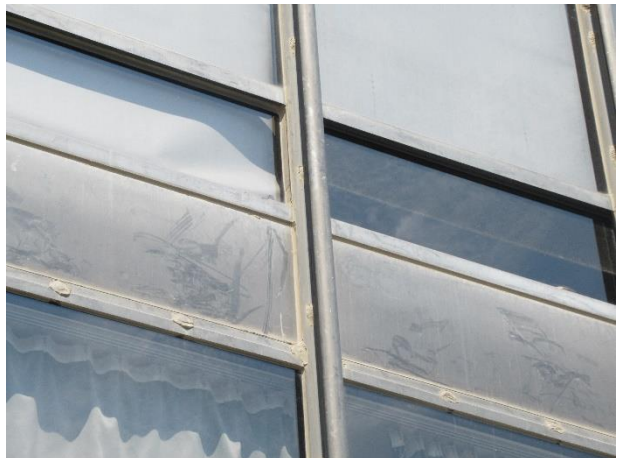
The spandrel panels and frames exhibit dirt/pollutant build-up. The spandrel panel conditions detract from the overall building aesthetics.

Spandrel panel conditions

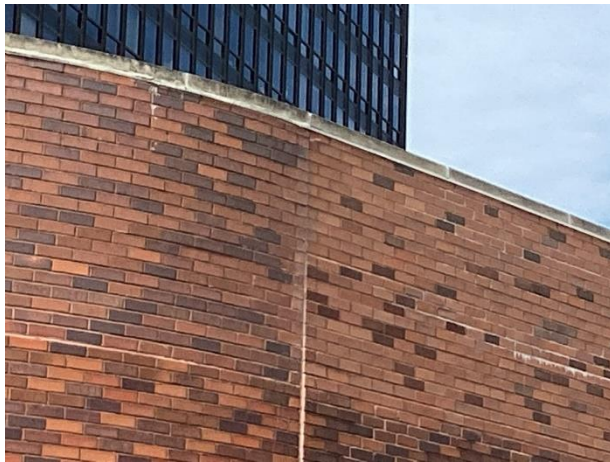
Evidence of water infiltration at masonry

Based on the conditions, we strongly recommend that the Association budget for near term additional systematic preventative maintenance repairs.

Complete reconstruction of parapet walls would result in a significantly greater cost. The exact cost of repairs is indeterminate at this time pending an engineering analysis to determine the required scope of repairs.

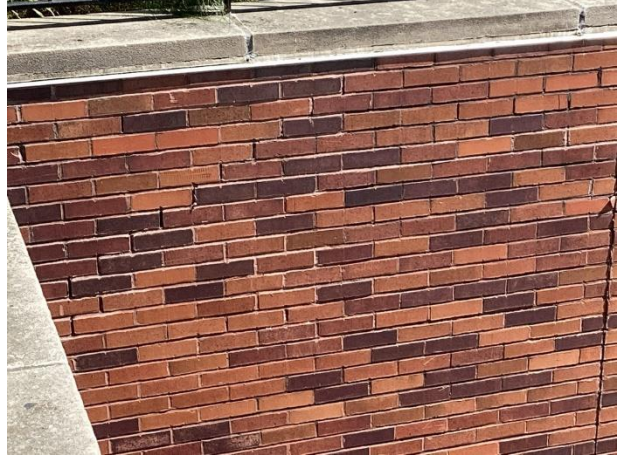
Masonry crack

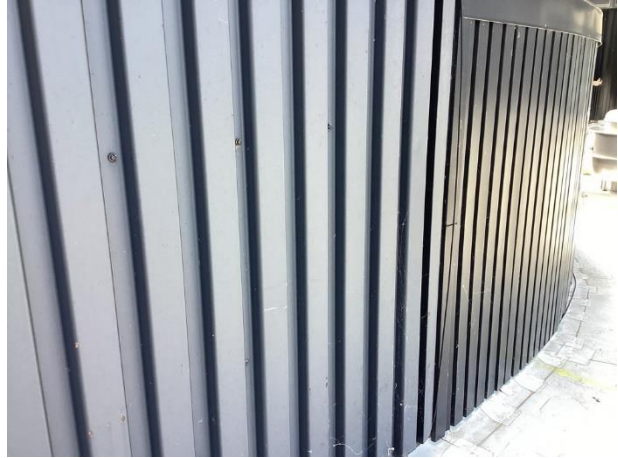
Siding color variations

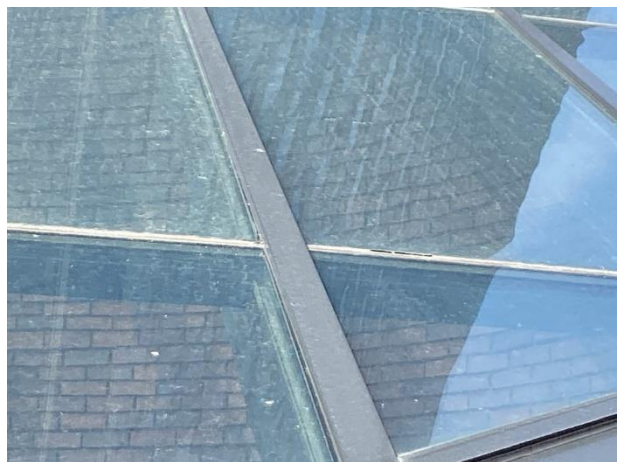
Skylight at joint sealant deterioration

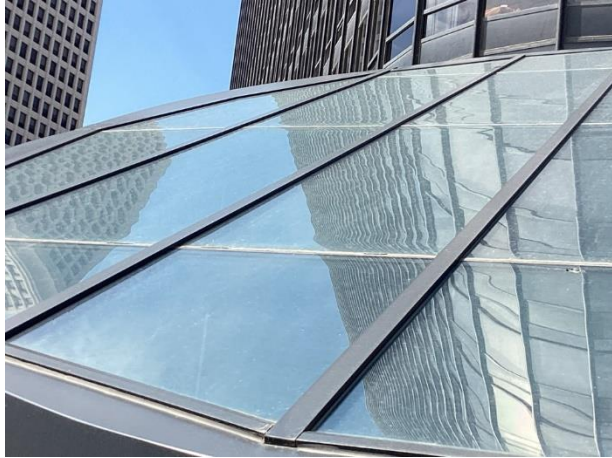
Skylight at joint sealant deterioration

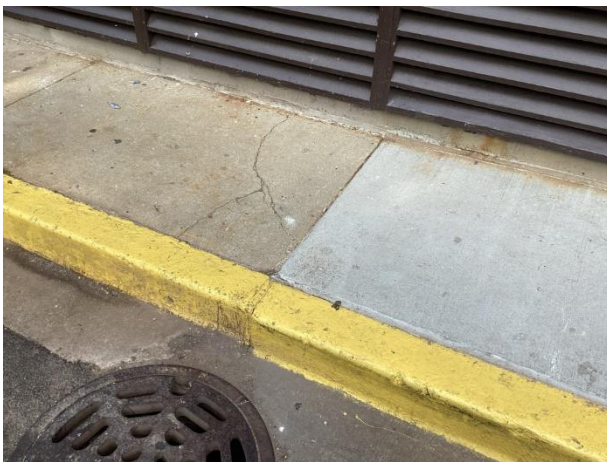
The concrete varies greatly in condition. Areas of cracks are evident, primarily at the service dock areas. We include periodic allowances for partial replacements of site concrete as the development ages.

Crack at sidewalk

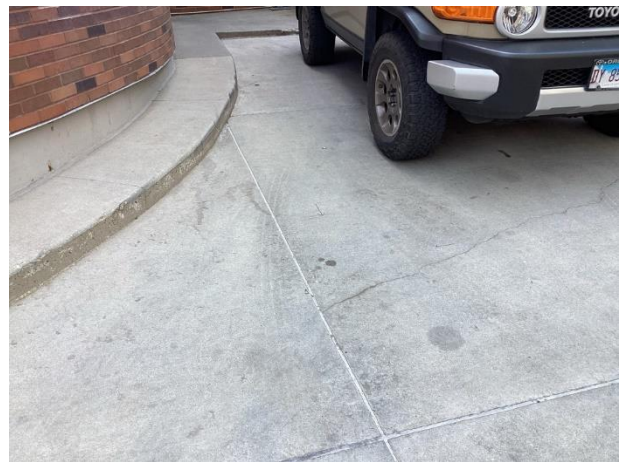
Service area pavement cracks

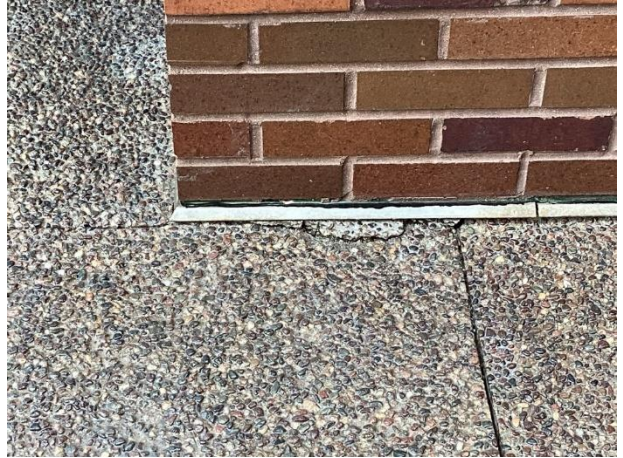
Crack at perimeter at plaza

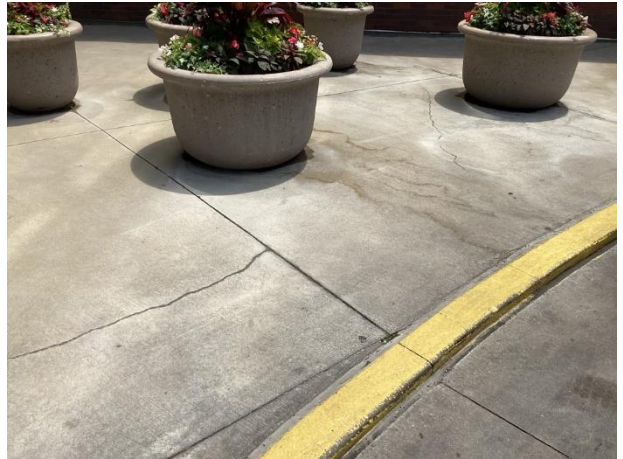
Cracks at concrete

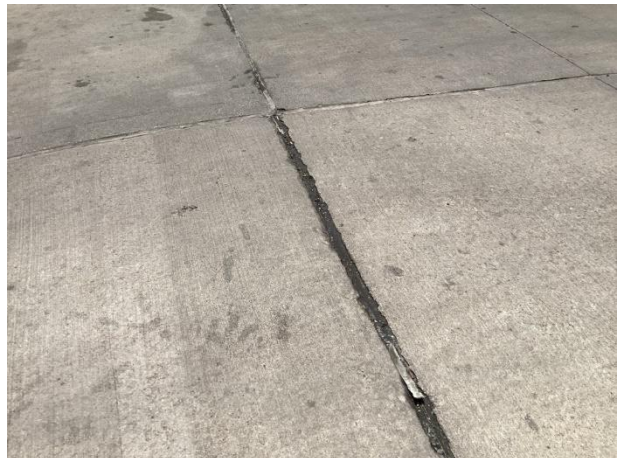
Driveway joint deterioration

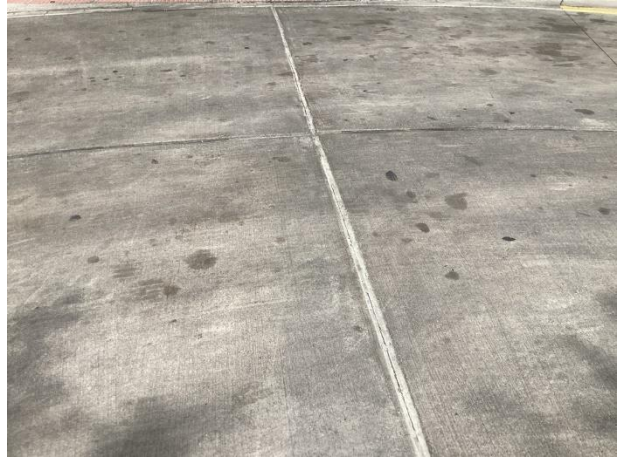
Joint deterioration at driveway

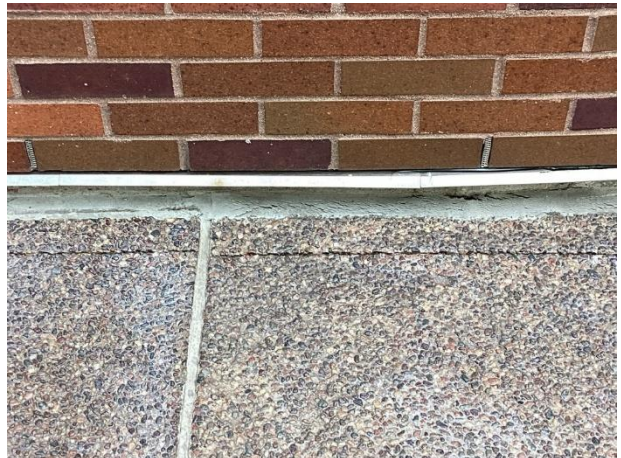
Joint deterioration at plaza

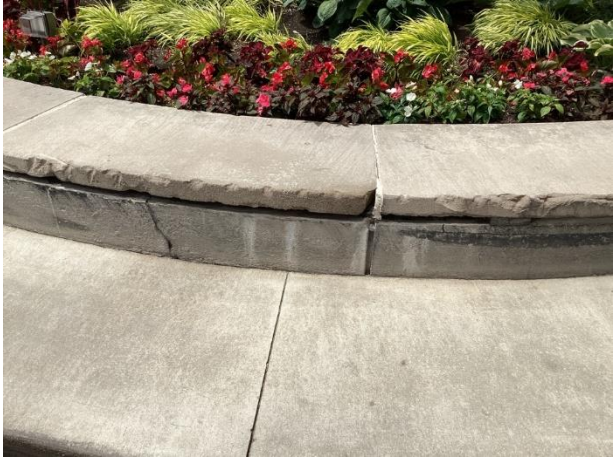
Planter joint deterioration

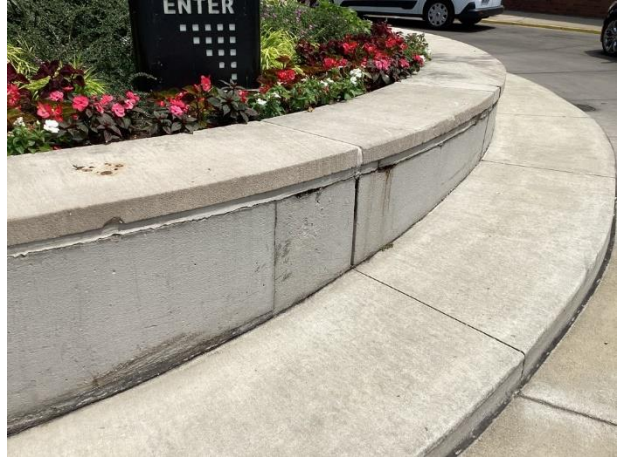
Planter wall cracks

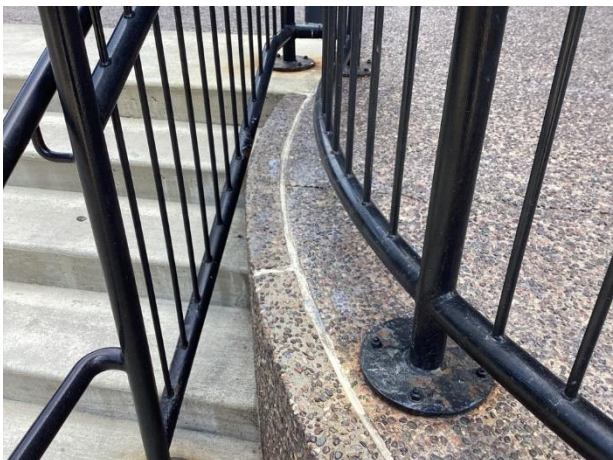
Rust at mounts at railing

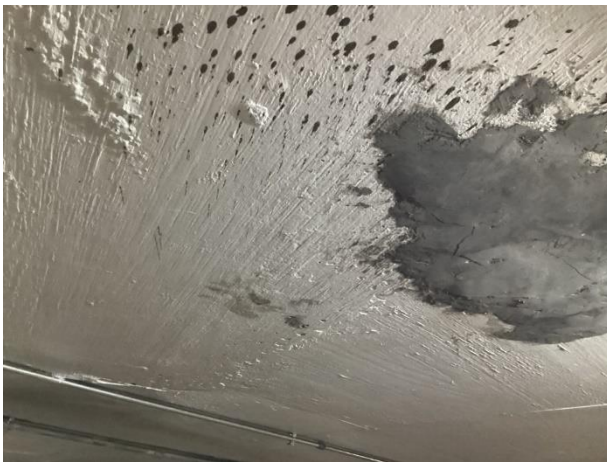
The ceiling beneath the elevated floor exhibits a significant amount of concrete repairs and isolated repair material cracks.

Crack at repair beneath elevated floor

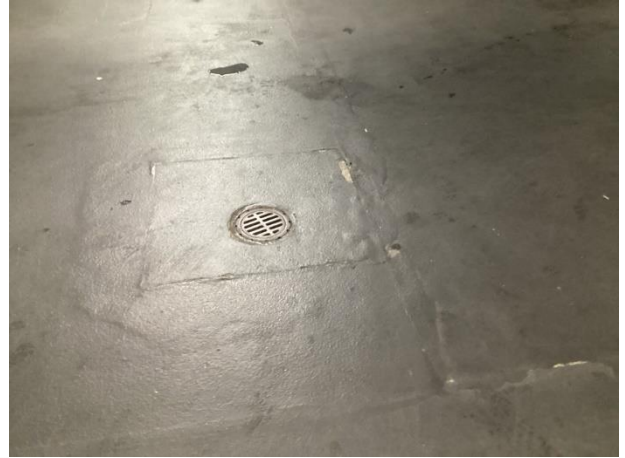
The traffic coating exhibits isolated areas of deterioration/damage, primarily at ramps and drive lanes. The Association will conduct limited traffic coating repairs through the warranty in 2024.

Traffic coating damage

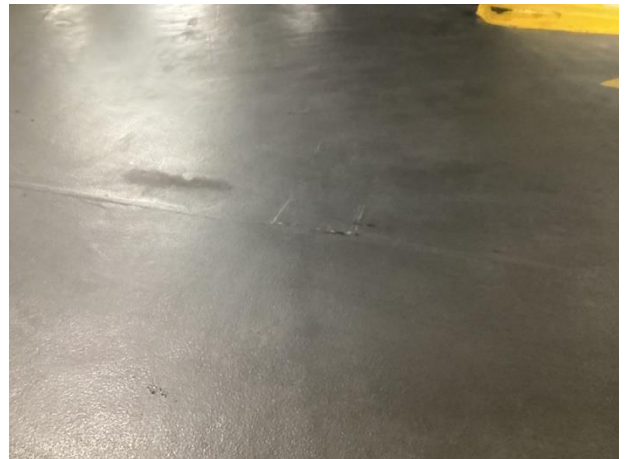
Traffic coating damage

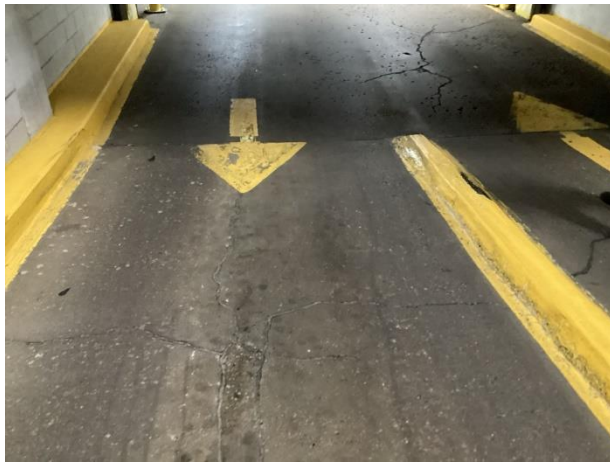
Condition: Conditions vary with areas of cracks, deterioration of original and repaired concrete, and surface spall evident.

Concrete cracks

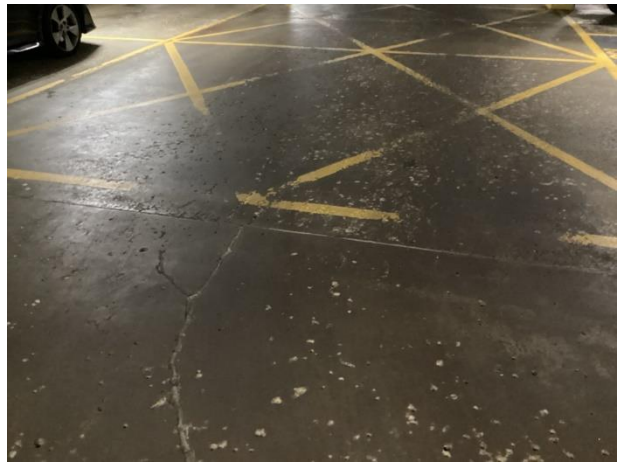
Concrete spall
