Park Tower Condominium Association

June 19, 2024 • Chicago, IL

Park Tower Condominium Association
Chicago, Illinois

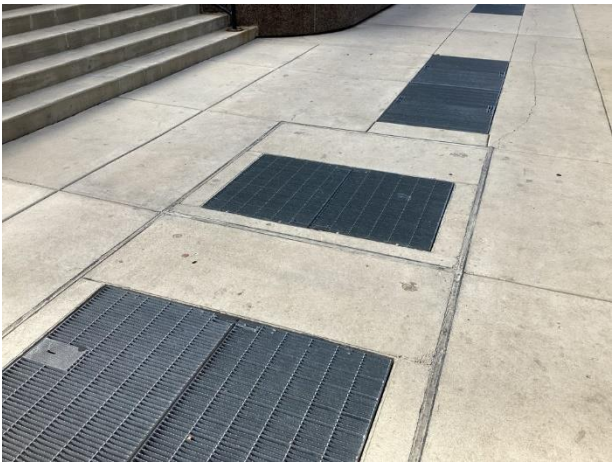
Electrical utility vault at west perimeter

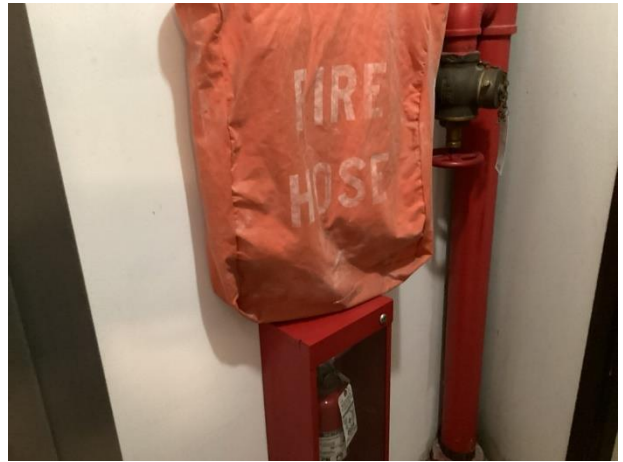
Fire hose and extinguisher

- Exhaust Systems (Except Garage, Main Kitchen and Main Rest Room)
- Fire Hoses and Extinguishers (We assume timely testing and replacements as needed through the operating budget.)

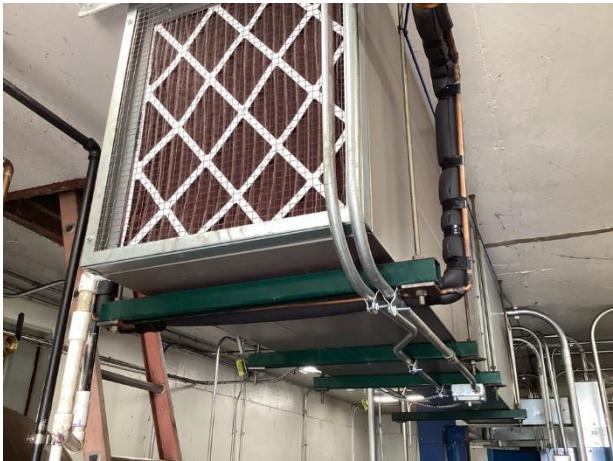
High rise elevator room air handling unit

- Air Conditioning and Heating Systems, Miscellaneous (Including Common Fan Coil Units, Baseboard Radiators and Window Units)
- Air Handling and Condensing Units, Elevator Room, High Rise (Condensing unit replaced in 2023)

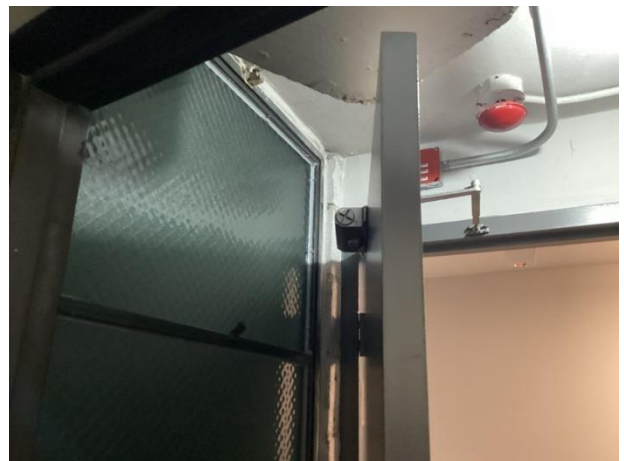
Smoke damper system

• Signage, Miscellaneous
• Smoke Damper System (Indeterminate Remaining Useful Life) (The need for systematic component replacements varies greatly. Management informs us that the Association conducts inspections and repairs as needed through the operating budget. We classify as operating budget funded per Management.)

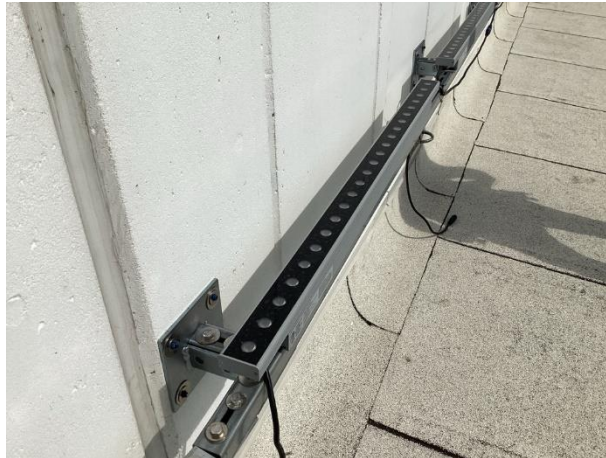
Component Detail Notes: The Association will complete installation of perimeter light fixtures at the main roof level, mounted to the penthouse structure walls. Park Tower will utilize Association staff to complete the installation.

Light fixture mock up

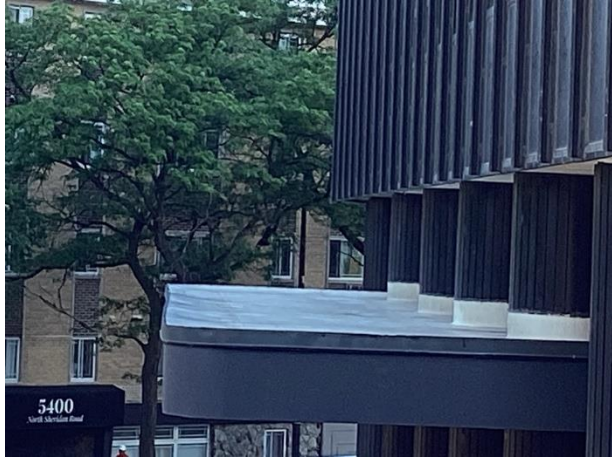
- **Tower, Main and Mechanical Penthouse** – 10,300 square feet of modified bitumen roofing, replaced 2017, good to fair overall with areas of perimeter sealant deterioration, depressions, granular loss and previous repairs evident
- **Lobby Canopy** – 800 square feet of flat membrane roofing, replaced 2012

Lobby canopy roof

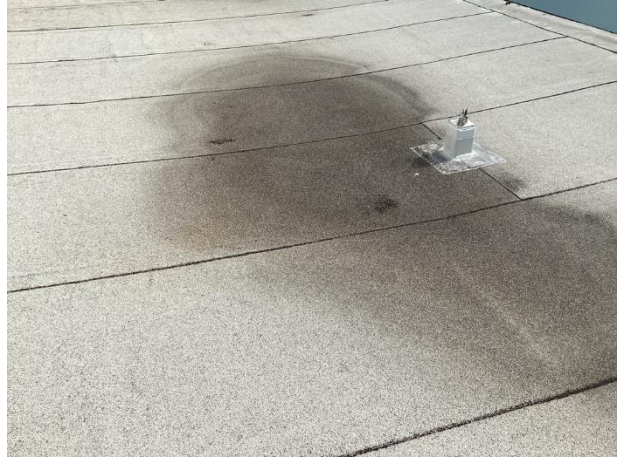
Depression at tower roof

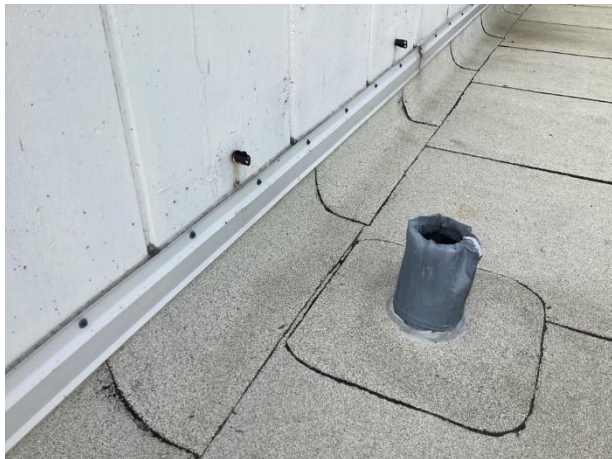
Penthouse roof at perimeter

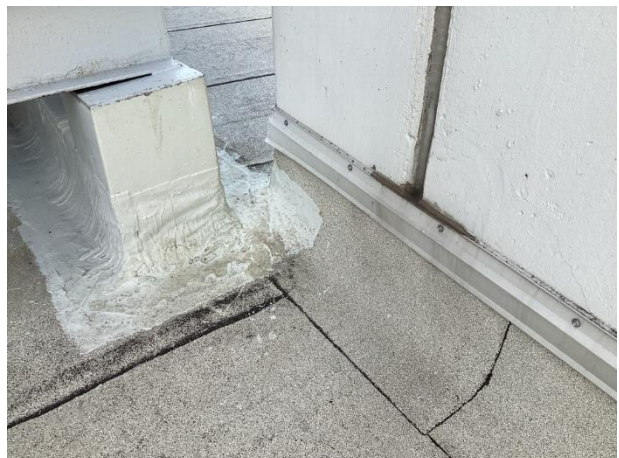
Tower roof system at perimeter

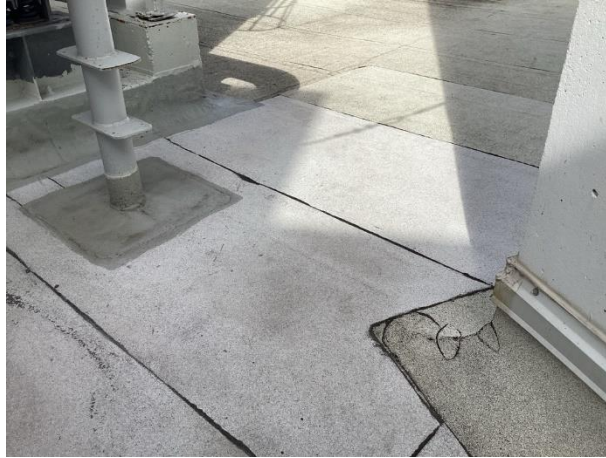
Tower roof system at repairs

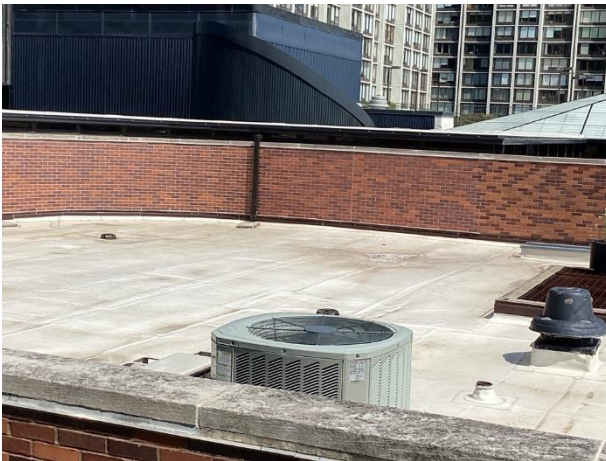
East or center roof at 2nd floor

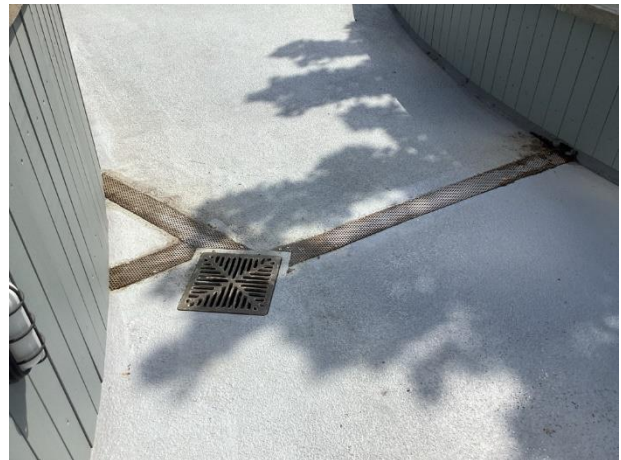
Waterproof coating at drains at 2nd floor roof

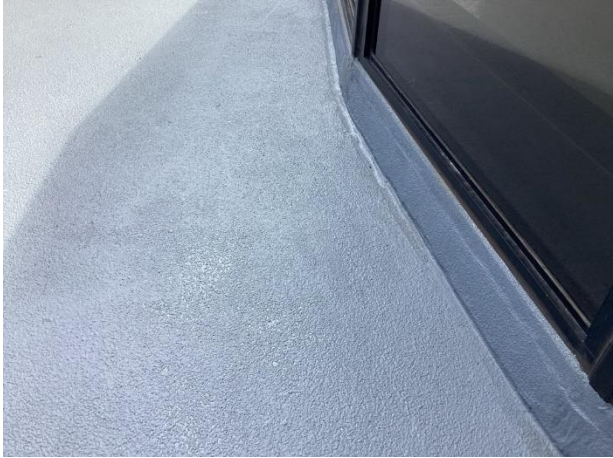
Waterproof coating at perimeter at 2nd floor roof

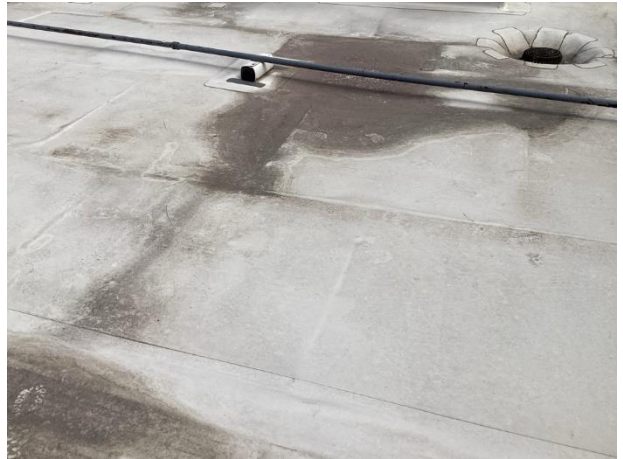
Northwest 2nd floor roof at depressions

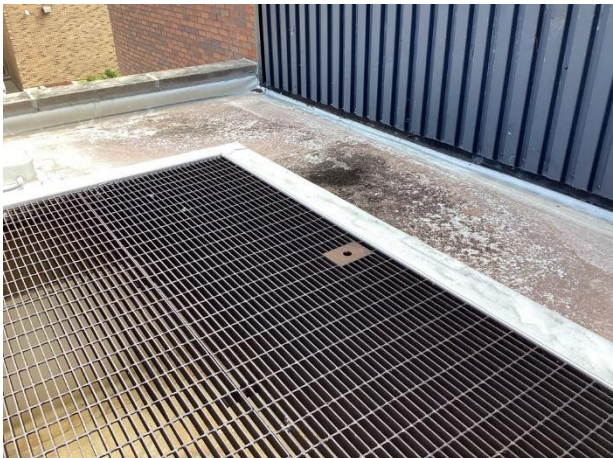
Northwest 2nd floor roof at lack of drainage

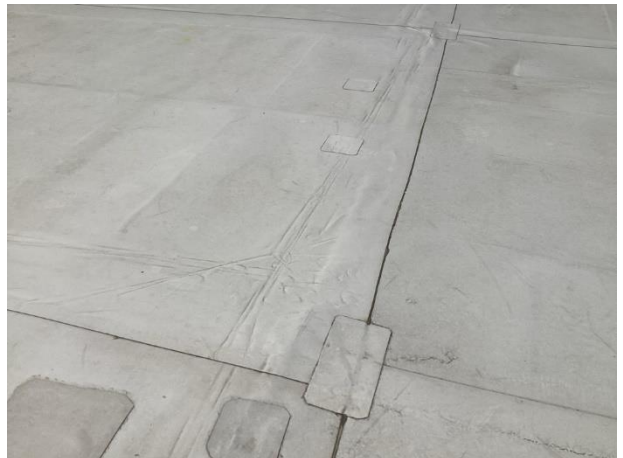
Patches at northwest 2nd floor roof

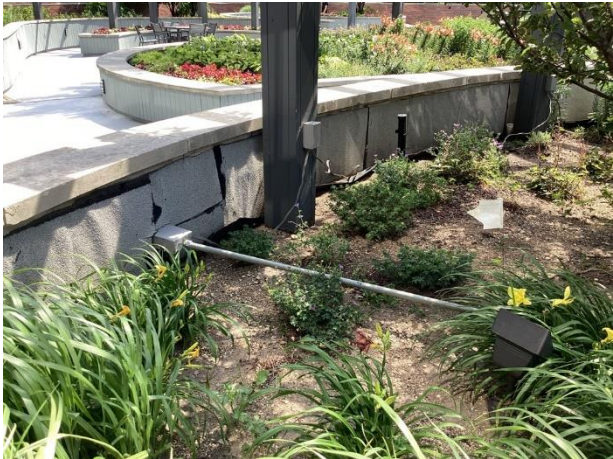
Membrane at perimeter at 2nd floor planter

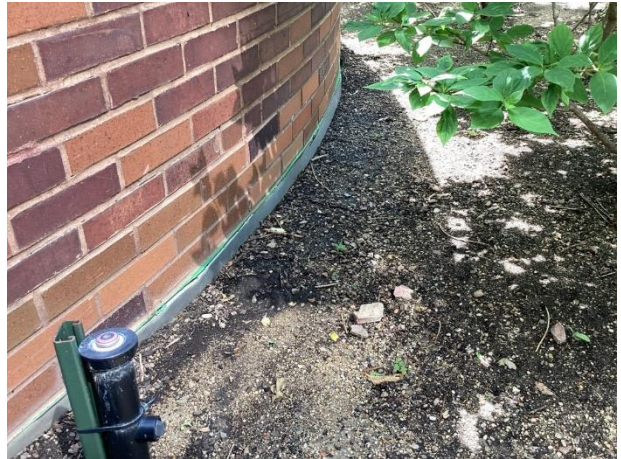
Perimeter flashing at 2nd floor planter

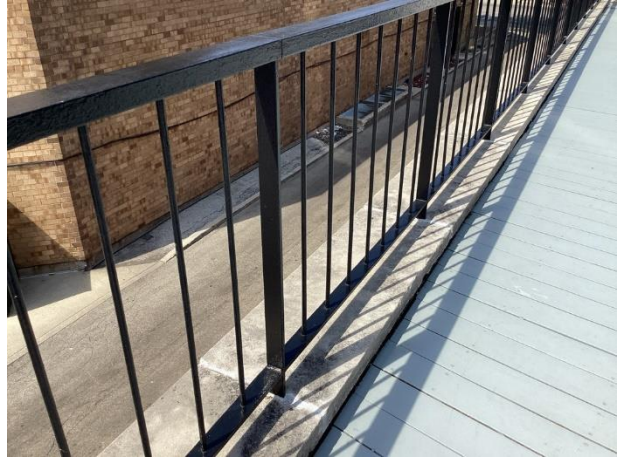
(pool area railings include glass panels), railings are original, the inset mounts accelerate masonry damage and steel corrosion, the railings east of the pool area exhibit extensive corrosion and areas of glass damage (We opine that the railing construction likely contributes to the masonry wall deterioration. We recommend installation of factory finished systems with a mount design that minimizes masonry deterioration.)

Steel railing at south perimeter of 2nd floor

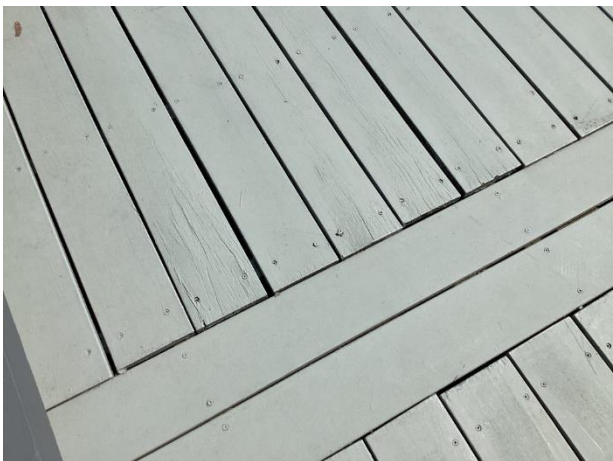
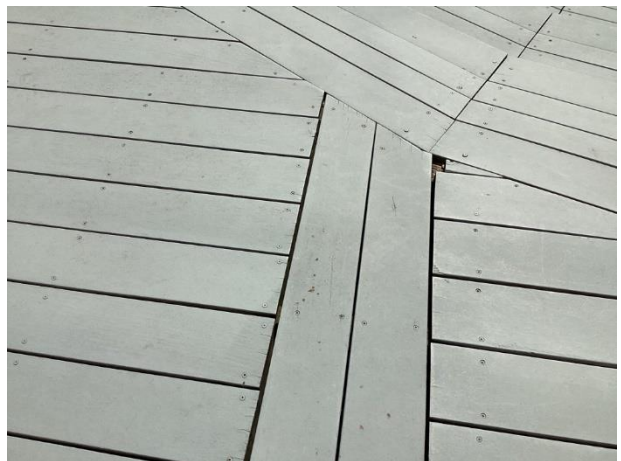
Weathered wood decking at 2nd floor roof

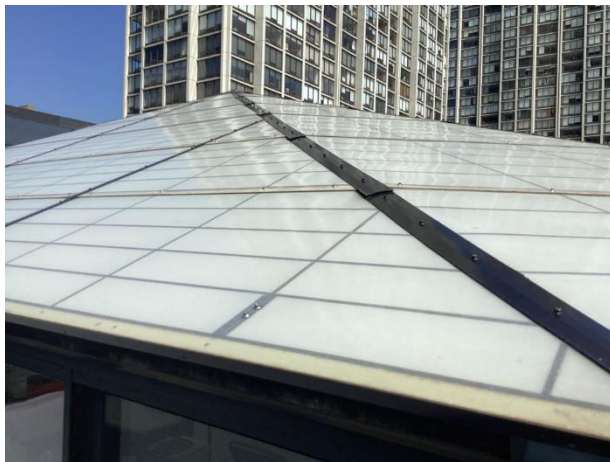
The Association replaced the roof system in 2023.

The roof system is in reported satisfactory condition.

Pool enclosure roof

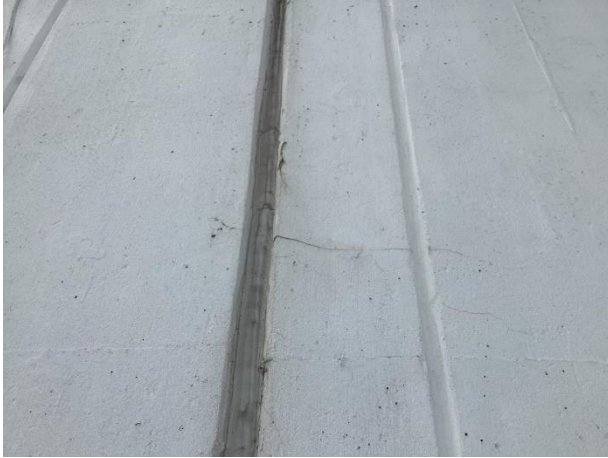
The concrete exhibits a significant amount of unrepaired cracks. Based on the conditions, we recommend that the Association budget for systematic preventative maintenance repairs.

Crack at joint at penthouse structure

- Complete inspection
- Partial depth replacement of a limited amount of concrete
- Crack repairs as needed
- Coating application

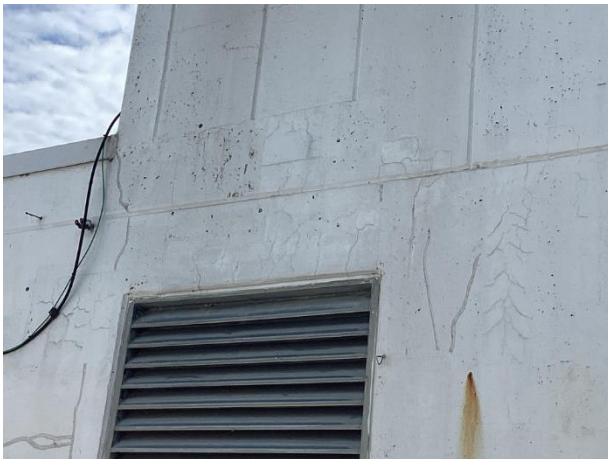
Cracks at penthouse structure

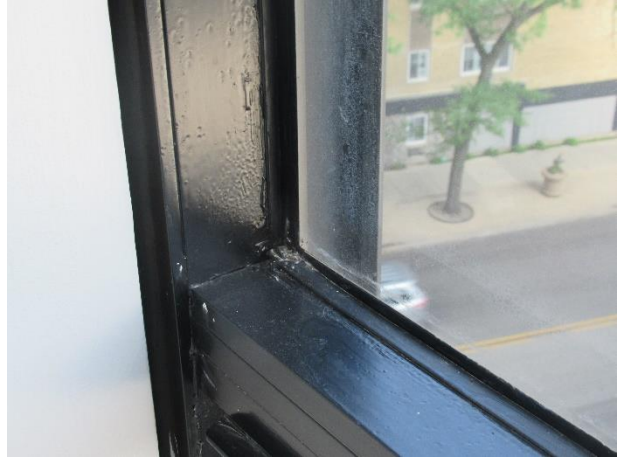
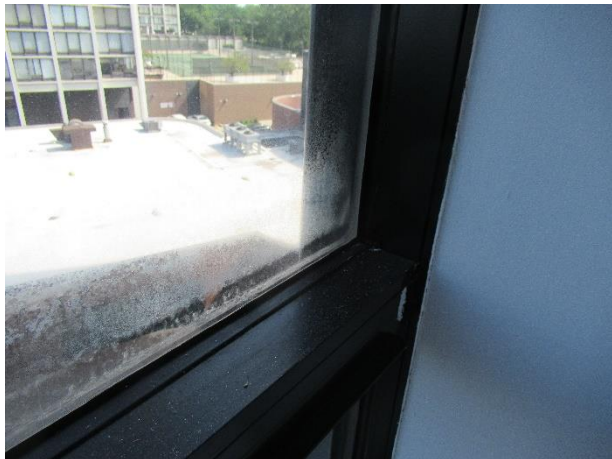
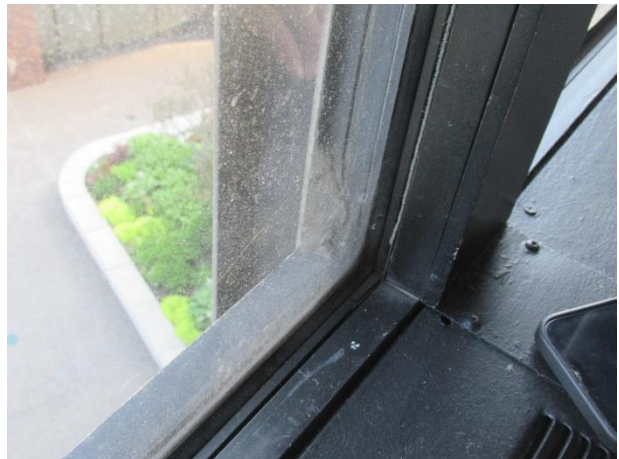
The curtain wall system exhibits isolated areas of exterior sealant deterioration. The weather stripping at unit interiors varies greatly in condition.

Curtain wall at interior seal

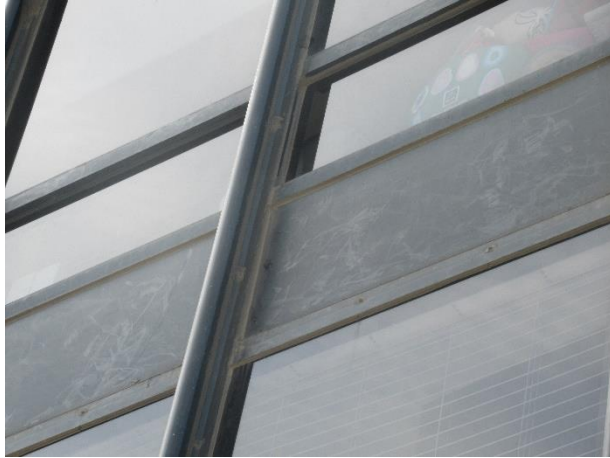
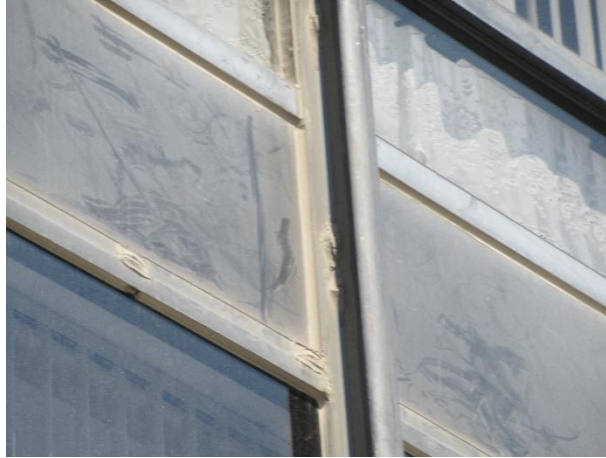
The spandrel panels and frames exhibit dirt/pollutant build-up. The spandrel panel conditions detract from the overall building aesthetics.

Spandrel panel conditions

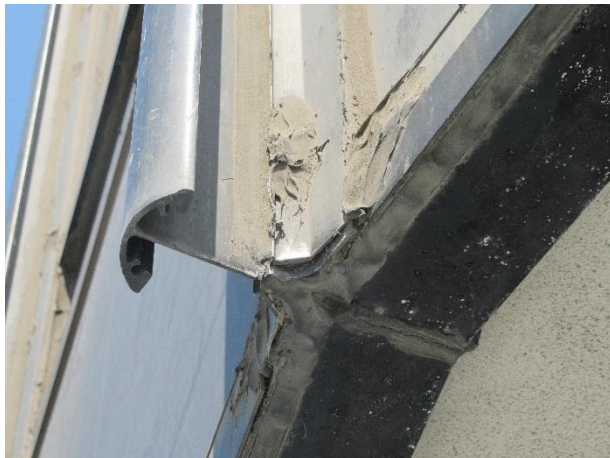
Sealant cracks at vertical mullion base

- Complete inspection of the curtain wall
- Replacement of eighty percent (80%) of the sealants
- Replacement of a limited amount of glazings
- Invasive inspection of a limited amount of anchors and refastening of aluminum components as needed
- Cleaning of the spandrel panels
- Touch-up finish applications
- Sidewalk protection
- Engineering allowance

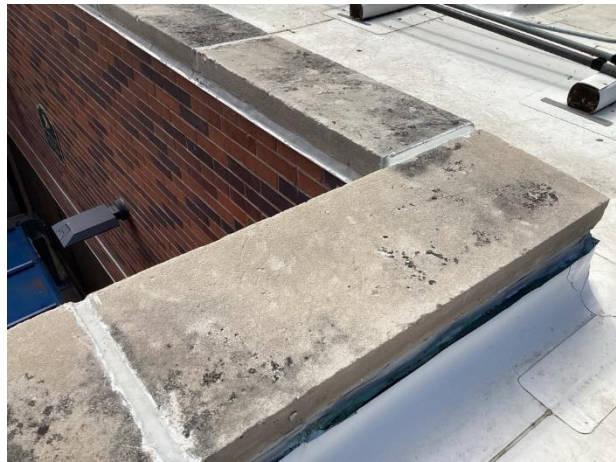
- Face brick masonry
- Parapet wall caps include varied flashing/weep systems
- Parapet wall caps exhibit areas of joint deterioration
- Flashing at the base of the masonry is evident (through wall flashing is not evident at locations other than the base of the walls)
- Masonry exhibits areas of joint deterioration, cracks, spall and damage at elevations not addressed during the plaza project
- Sealant deterioration is evident at control joints
- Parapet walls exhibit evidence of water infiltration

Flashing at wall caps

- Complete inspection of the masonry
- Repointing of up to fifteen percent (15%) of the masonry
- Replacement of a limited amount of masonry
- Flashing and weep installation/replacement at caps and shelf angles as needed
- Parapet wall cap joint repairs as needed

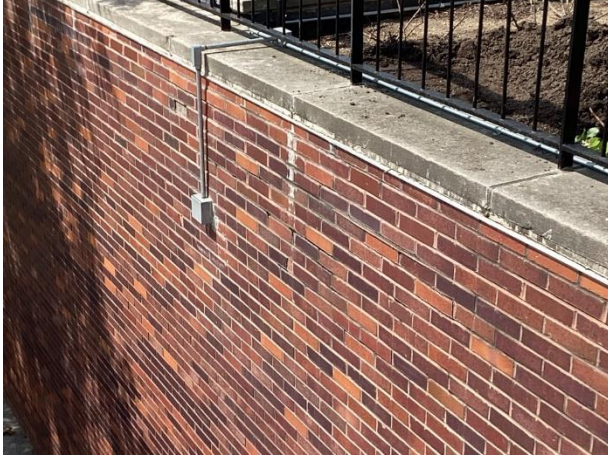
Masonry crack and spall

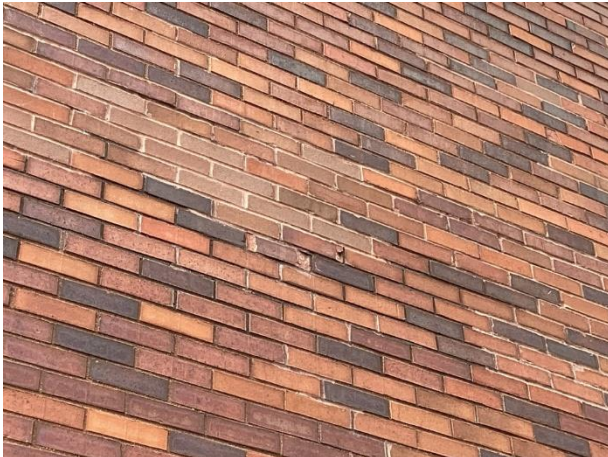
Masonry spall and joint deterioration

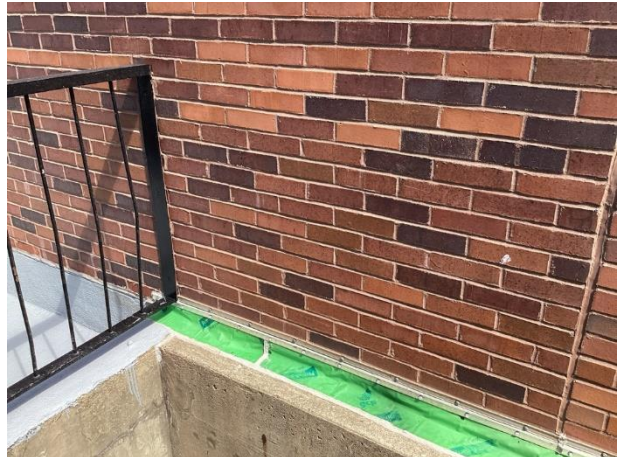
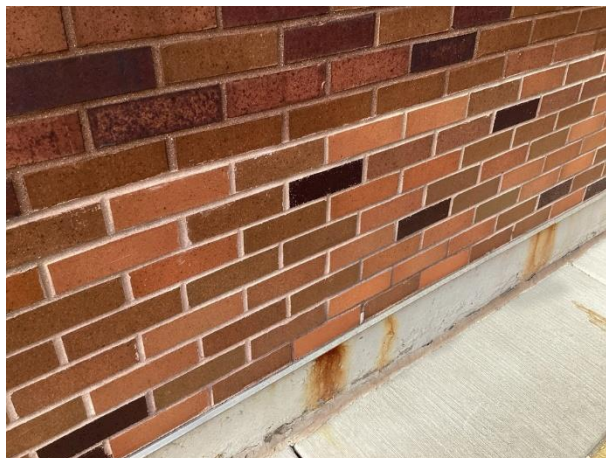
Recent masonry repairs and flashing installation

Replaced masonry and flashing installation

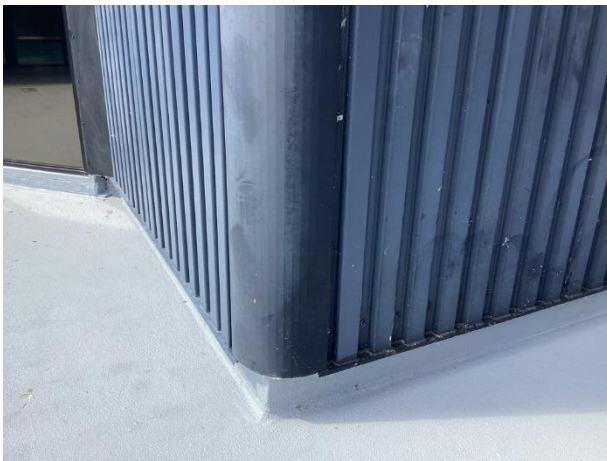
The siding exhibits areas of damage and isolated corrosion at the base of the panels.

Metal siding at base

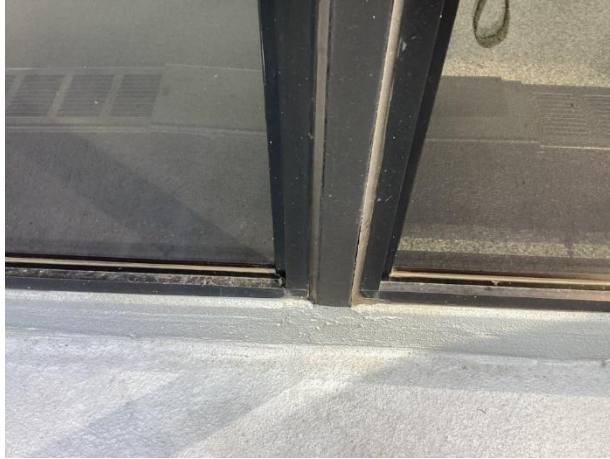
Walkway window system at joint sealant deterioration

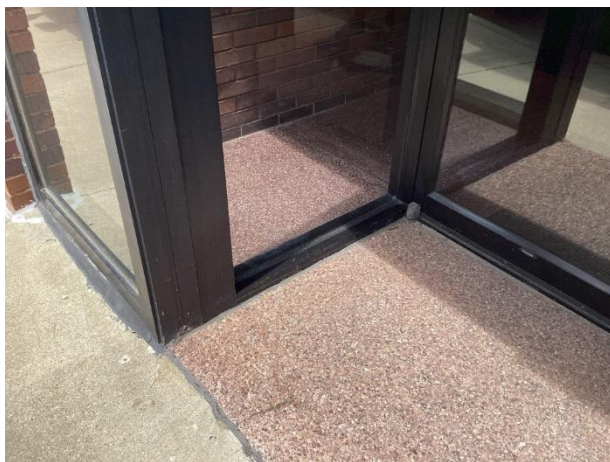
- **Mall** – Management informs us that the commercial entities are responsible for their window systems, the Association maintains the common entrance areas, the common entrance areas comprise aluminum frame systems, primarily original, fair overall with areas of damage evident

Window and door system at entrance at mall

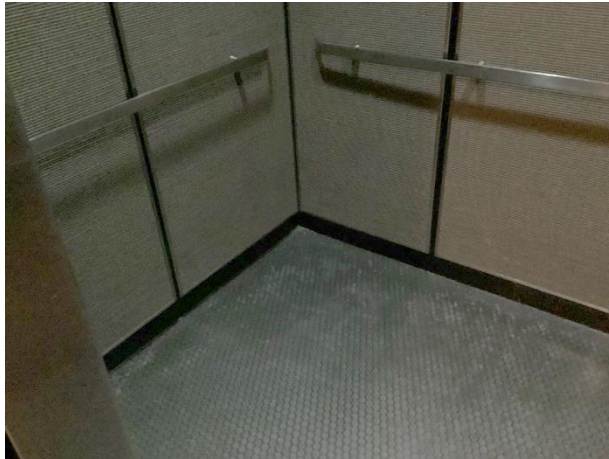
- **Traction, Passenger** – four elevators, Association refinished the walls in 2014, poor overall, we include a Management provide cost to replace these finishes in the near term
- **Traction, Service** – two elevators, Association staff removed the #6 cab recently, the near-term elevator cab finishes project includes code upgrades and replacement of the #5 ceiling, we assume interim limited subsequent renovations as needed through the operating budget
- **Hydraulic, Garage/Mall** – two elevators, fair overall, we defer systematic renovation at the direction of Management

Elevator 6 cab finishes

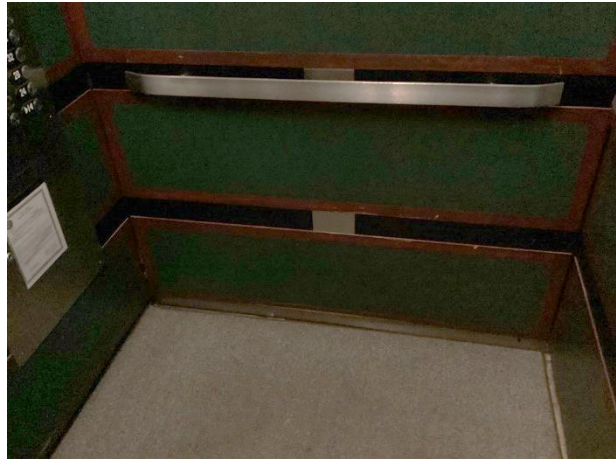
Elevator cab finishes for passenger elevator

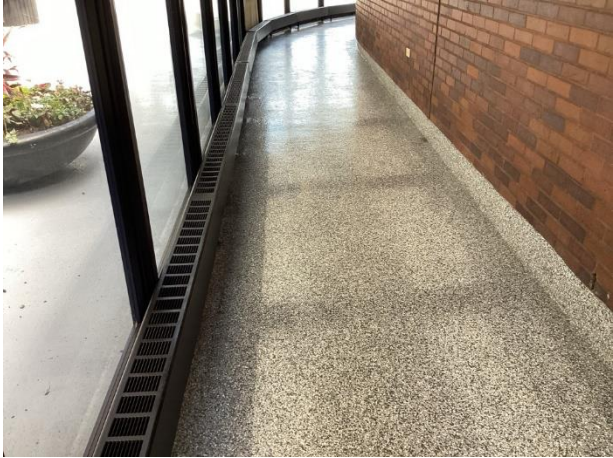
Condition: Good overall

Coating at floor at walkway

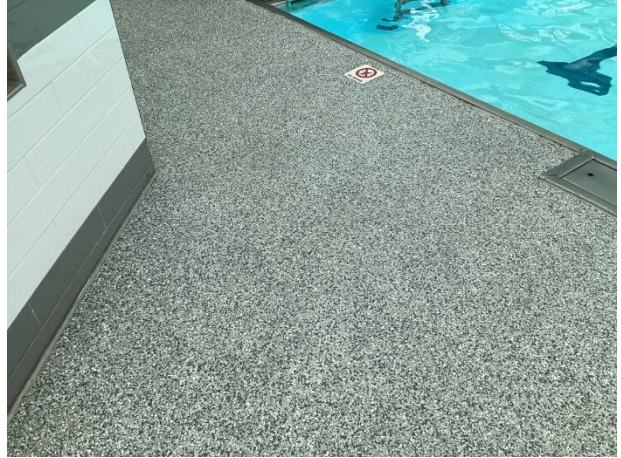
Pool deck coating

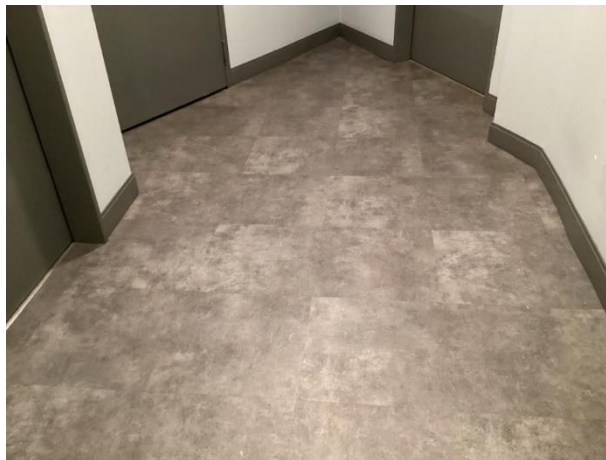
Condition: The replaced flooring is in good overall condition.

Service area flooring

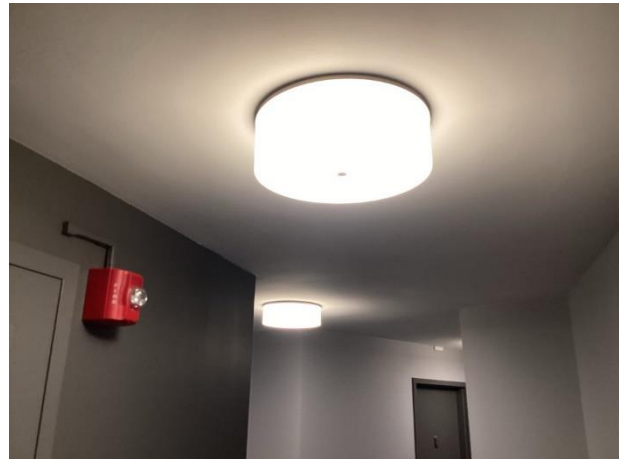
Recently replaced light fixtures

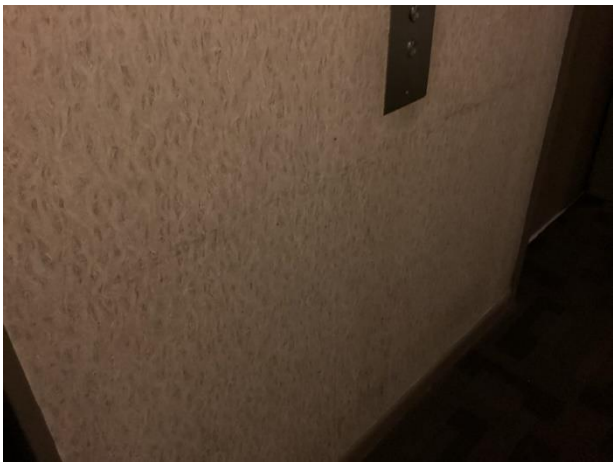
Dated wall covering

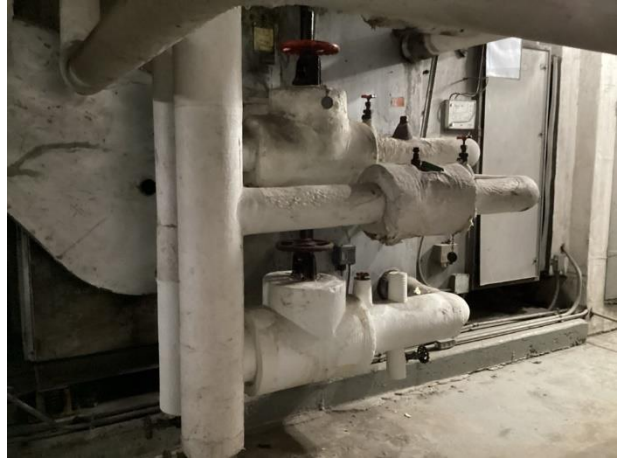
- **Lobby** - one unit, 18,950-CFM, original coils, system includes a return air fan, the Association will replace the dampers at the lobby unit and other air handling units in the near term, the lobby coils are in reported satisfactory condition

Lobby air handling unit

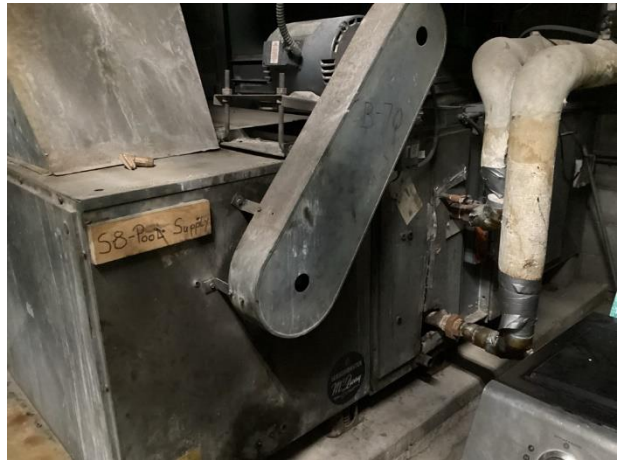
- **Pool** - one unit, includes a return air fan, 9,370-CFM, coils replaced 2012, the Association will likely replace the motor in the near term
- **Racquetball Courts** - one *American Standard* packaged rooftop unit for the racquetball court and strength training exercise room, replaced 2024,

Pool air handling unit

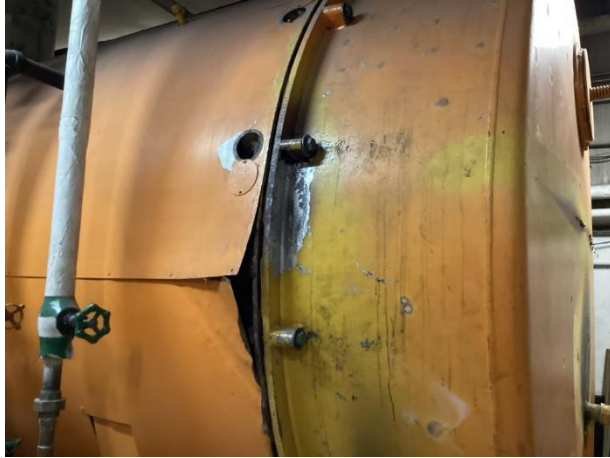
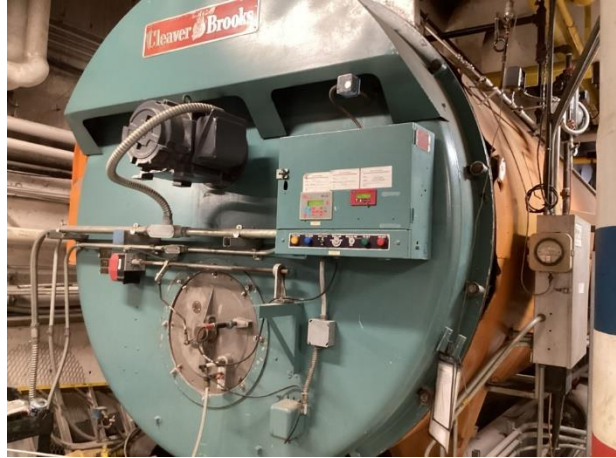
History: The boilers are original. The Association replaced the burners and controls in 2013. The Association replaced the front and back refractory and tubes as needed in 2021 at both boilers. The Association recently replaced approximately 20 tubes.

Condition: Reported satisfactory without operational deficiencies

Building heat boiler at shell

Building heat boiler

For purposes of this Reserve Study, we defer total replacement and partially reduce the unit cost based on information provided to Management by a contractor familiar with the boiler system at Park Tower. *However, we opine that the cost to design and replace the boiler system is low.*

Replacement of the boilers may allow for energy efficiency improvements through the following:

- Installation of lessor capacity boilers (The boilers were originally installed to provide building heat and domestic hot water.)
- Installation of high efficiency boilers

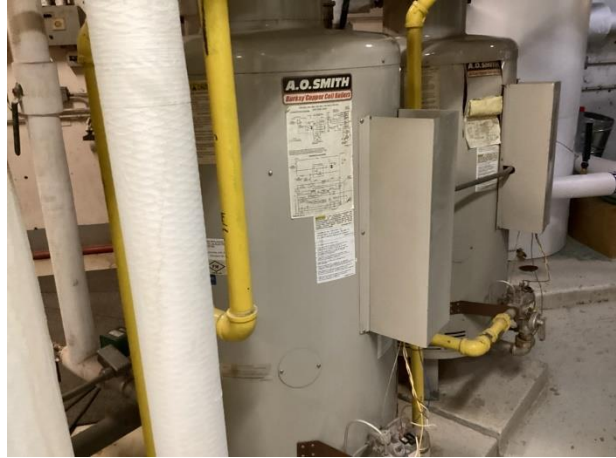
Condition: Reported satisfactory without operational deficiencies for the residential systems. The Building Engineer informs us of the potential need to replace the commercial systems.

Commercial domestic water boilers

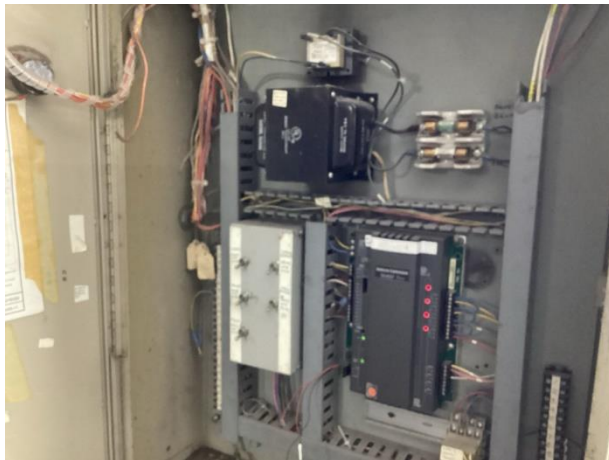
Condition: Reported satisfactory overall. The Association conducts partial improvements to the system concurrent with replacement of equipment.

The Building Engineer informs us that system will be discontinued in the near term and thus, replacement of control panels and the central system is a potential need in the near term.

Building automation system panel

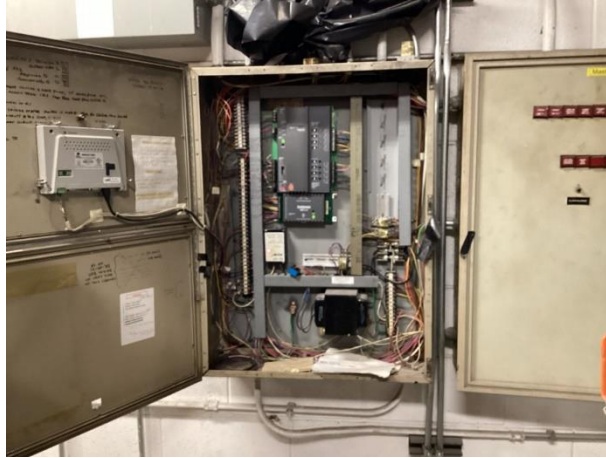
Main panel for heating system

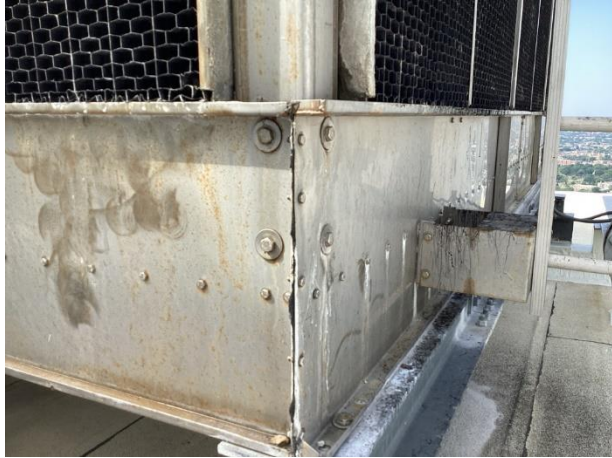
Condition: Reported satisfactory overall

Cooling tower at previous seepage

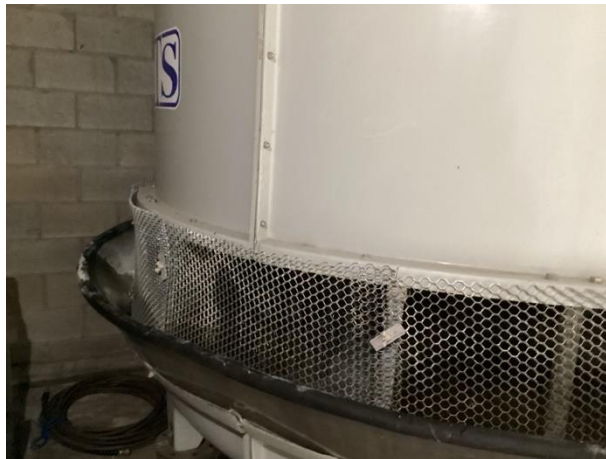
Commercial cooling tower

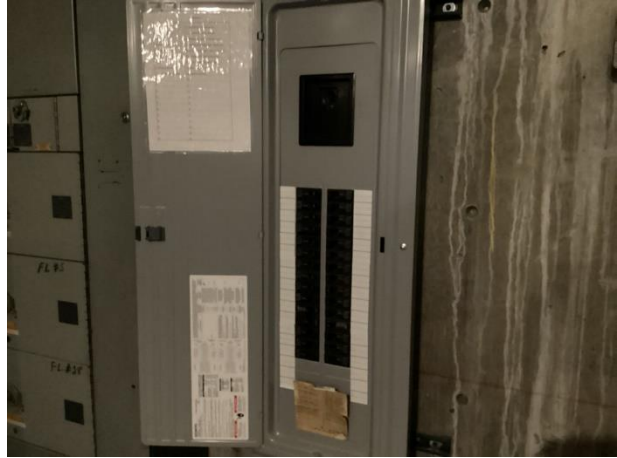
The Association recently installed infrastructure for electric vehicle charging stations. The Association replaced the lobby circuit protection panels in 2023 and the fuse type garage circuit protection panels in 2024.

Replaced circuit protection panel for garage

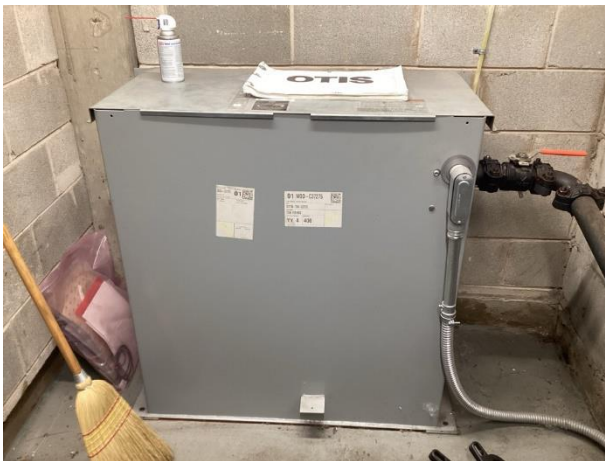
Refuse elevator power unit casing

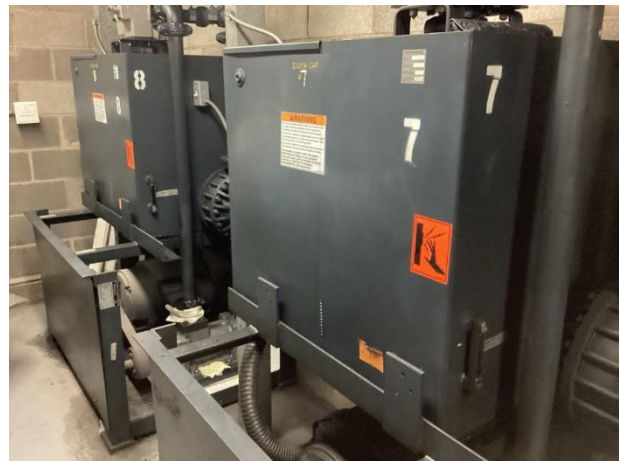
Condition: Reported satisfactory and service interruptions are reportedly infrequent.

Hydraulic elevator equipment for mall and garage

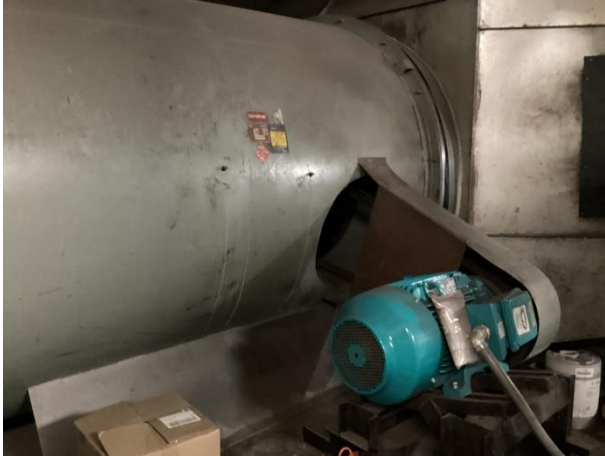
We include a Management provided expenditure to conduct component replacements at the rest room fan in the near term, including replacement of the shaft and bearings.

Recently replaced motor at exhaust fan

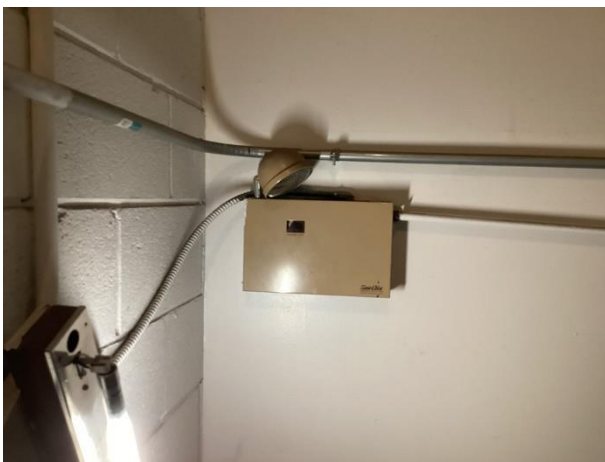
Emergency battery pack fixture

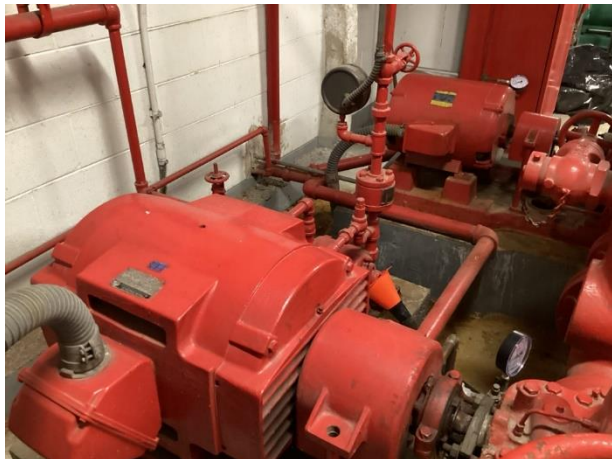
- **Fire Suppression** - one 100-HP, one 40-HP, two total, original, controls replaced in the 1990s, the systems include jockey pumps, the Association tests the pumps weekly

Fire suppression pumps

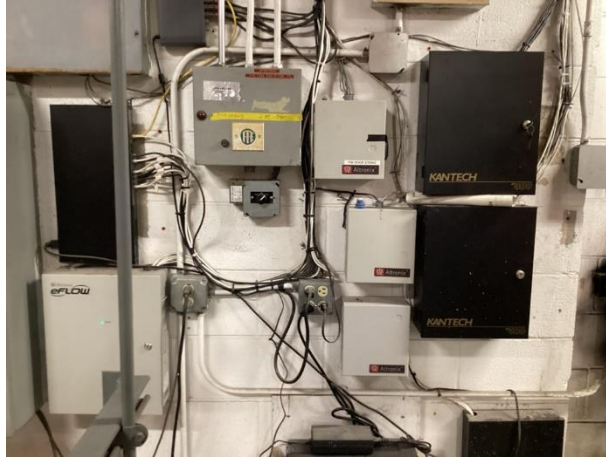
Condition: Reported satisfactory overall

Fob system control panels

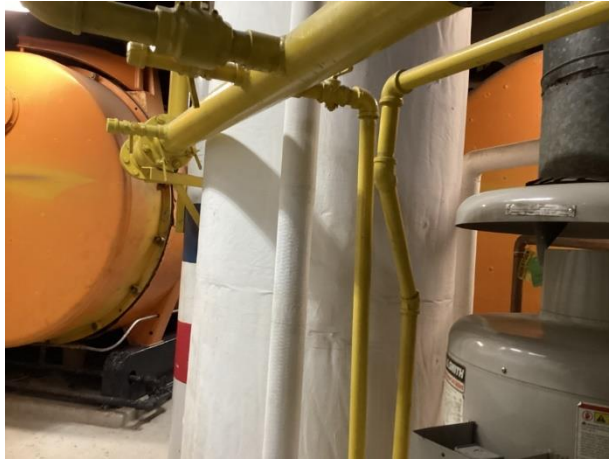
Commercial domestic water storage tank

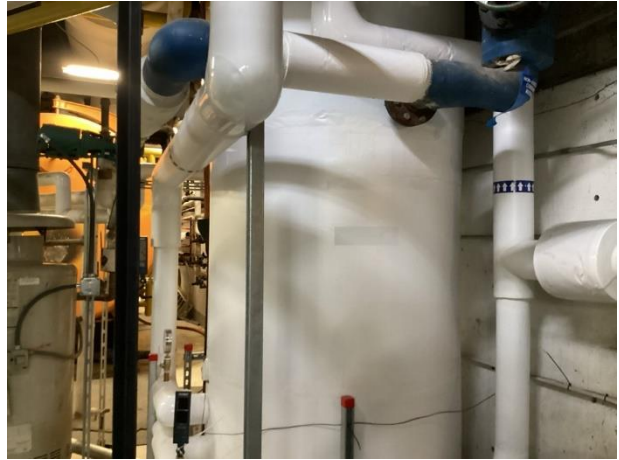
Low rise residential domestic water storage tank

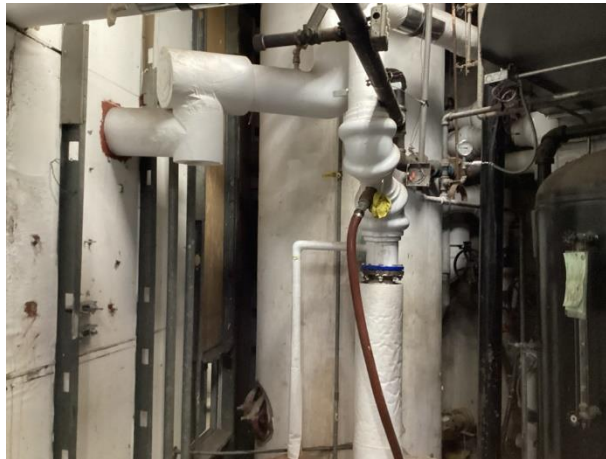
The high zone residential tank is original.

Penthouse domestic water storage tank

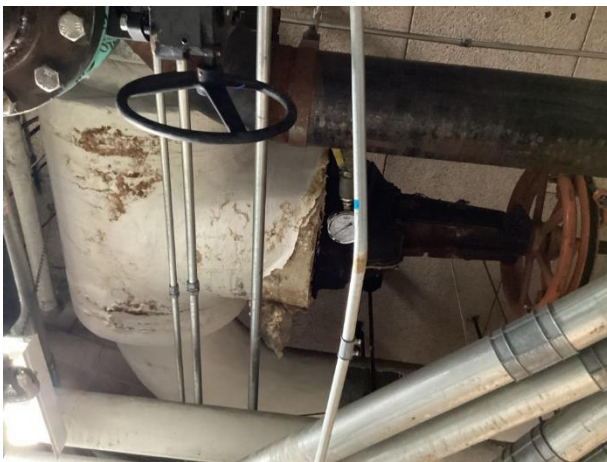
Chiller room large diameter valves

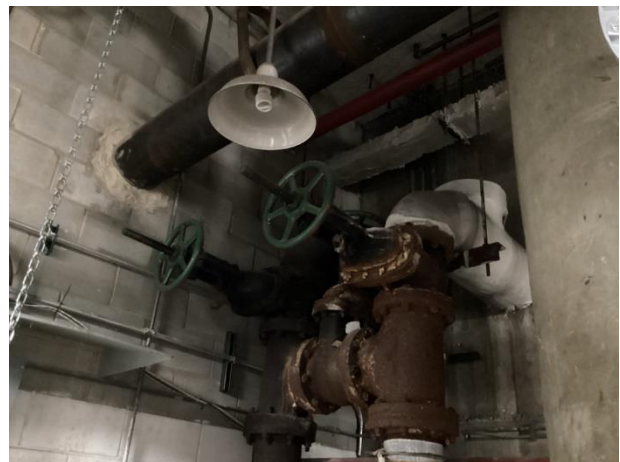
Condition: Reported satisfactory overall. Exceptions include three main water connection valves that the Building Engineer informs us will be replaced in the near term. We include a Building Engineer provided cost for this project.

Main water connection large diameter valves

We recognize that the Association may defer large diameter valve replacement to coordinate with replacement of the fire suppression pumps and boilers as a redesign of the system is likely.

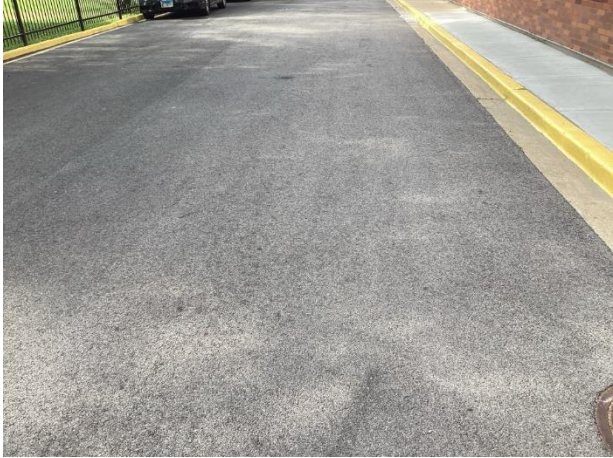
The pavement is in good overall condition with isolated cracks evident. We opine that the type and amount of traffic will likely result in a diminished useful life.

East perimeter pavement

existing asphalt down to the base course of aggregate and native soil followed by the application of two or more new lifts of asphalt. We recommend mill and overlayment on asphalt pavement that exhibits normal deterioration and wear. We recommend total replacement of asphalt pavement that exhibits severe deterioration, inadequate drainage, pavement that has been overlaid multiple times in the past or where the configuration makes overlayment not possible. Based on the apparent visual condition and configuration of the asphalt pavement, we recommend the total replacement method of repaving at Park Tower.

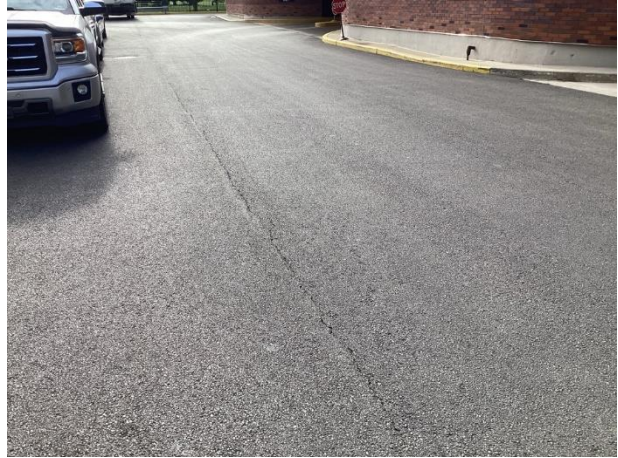
North perimeter pavement

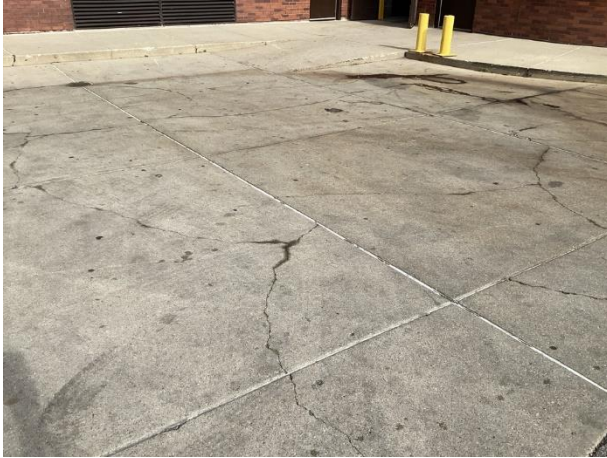
The concrete varies greatly in condition. Areas of cracks are evident, primarily at the service dock areas. We include periodic allowances for partial replacements of site concrete as the development ages.

Service dock pavement cracks

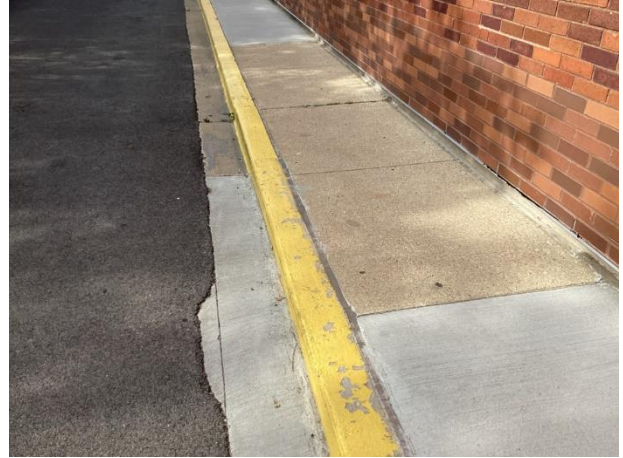
Varied sidewalk replacements
