Park Tower Condominium Association

June 19, 2024 • Chicago, IL

Park Tower Condominium Association
Chicago, Illinois

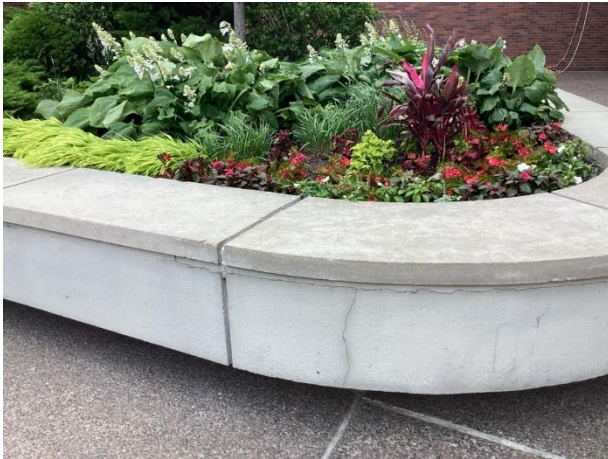
Condition: The concrete toppings exhibit areas of cracks and joint sealant deterioration. The concrete walls at the planters exhibit cracks. The ceiling beneath the plaza exhibits isolated evidence of water infiltration and a significant amount of previous repairs.

Crack at planter wall

We include a Management provided expenditure for planter wall repairs in the near term.

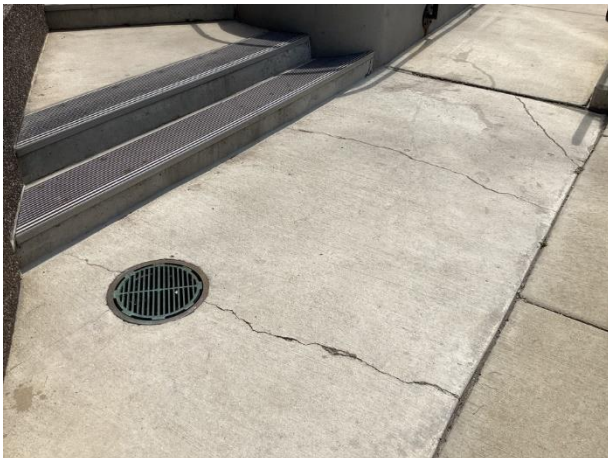
Cracks at concrete

- Replacement of sealants
- Crack repairs as needed
- Replacement of a limited amount of concrete topping
- Replacement of a limited amount of membrane (leak remediation)

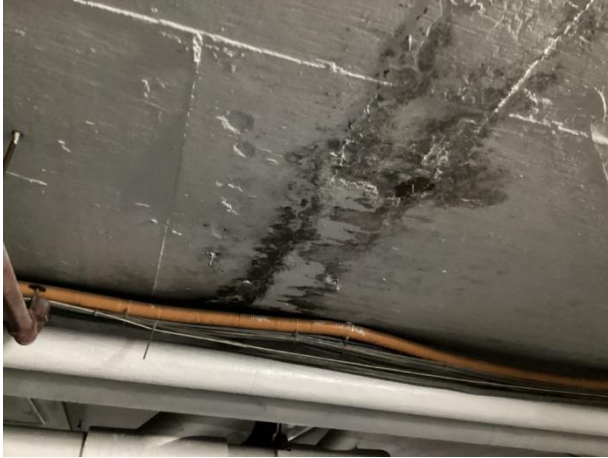
Evidence of past water infiltration beneath the plaza

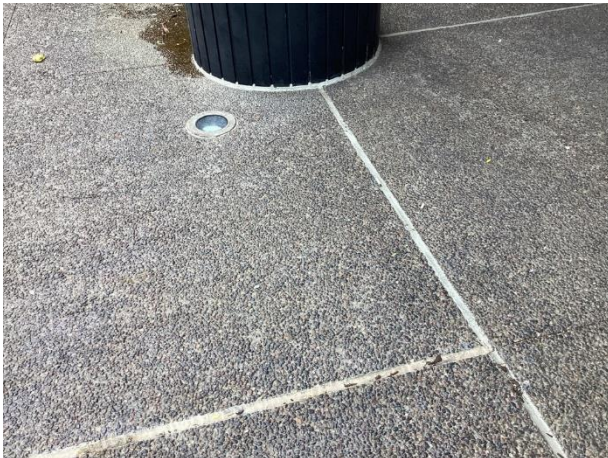
Joint deterioration at plaza

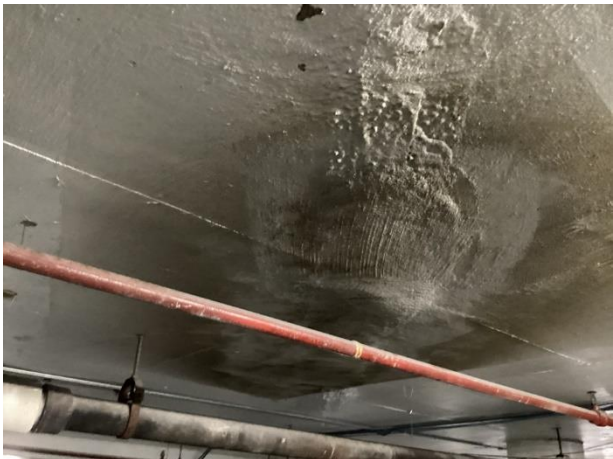
Repairs beneath plaza

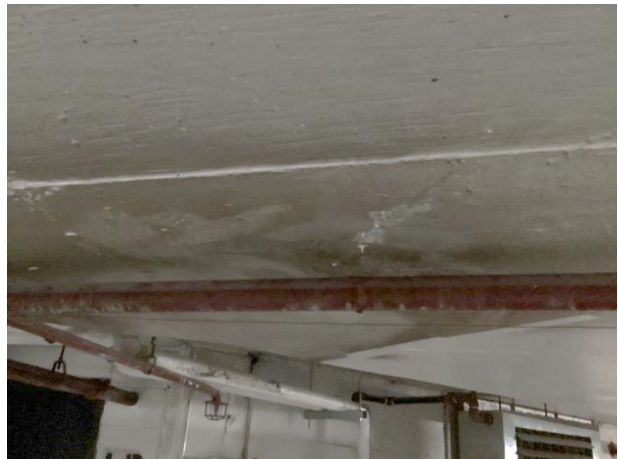
Repairs beneath plaza

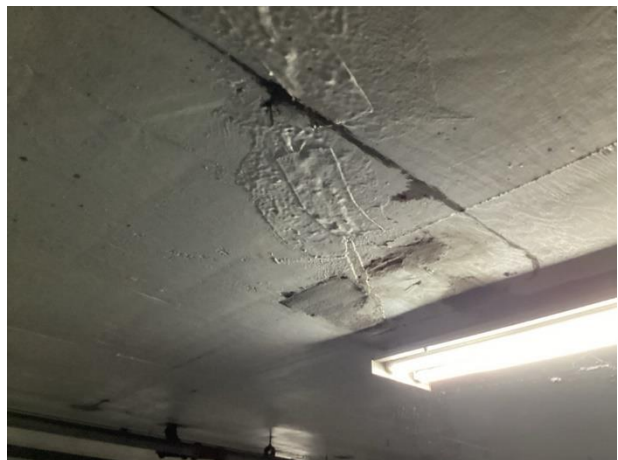
Typical repairs beneath plaza

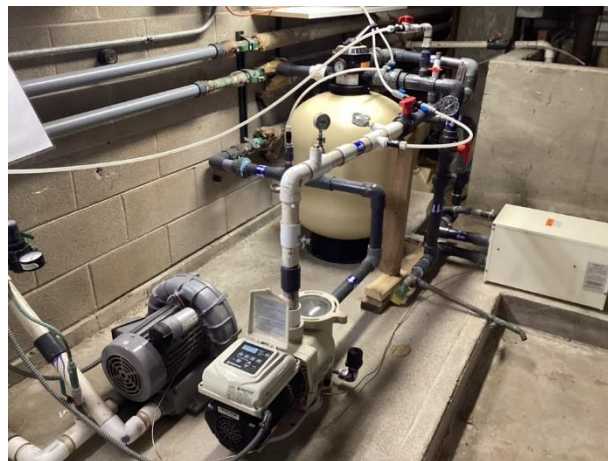
Spa mechanical equipment

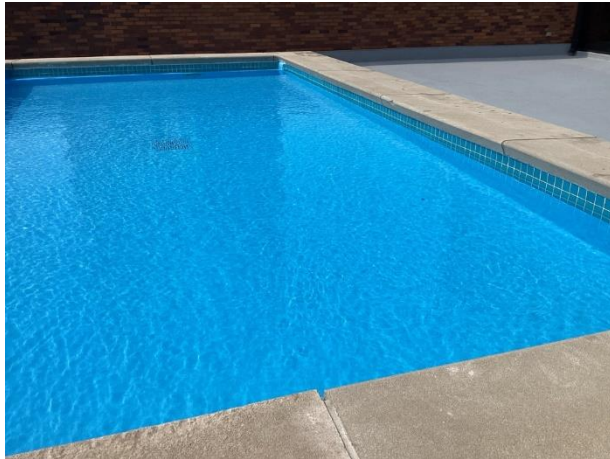
Outdoor pool plaster finish

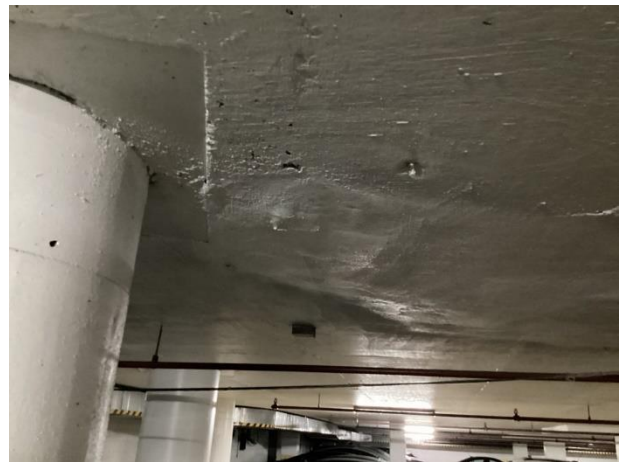
The ceiling beneath the elevated floor exhibits a significant amount of concrete repairs and isolated repair material cracks.

Repairs beneath elevated floor

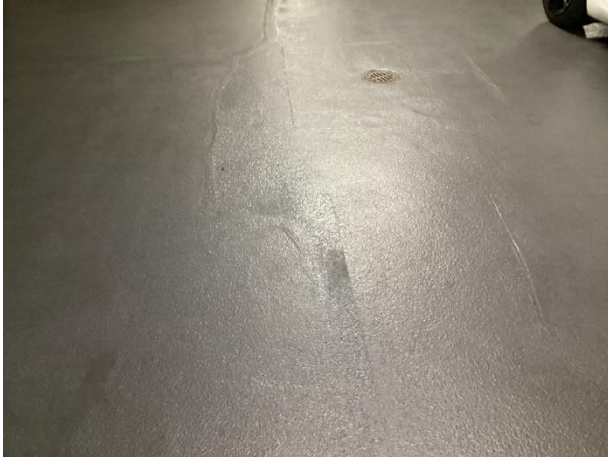
Repairs beneath traffic coating

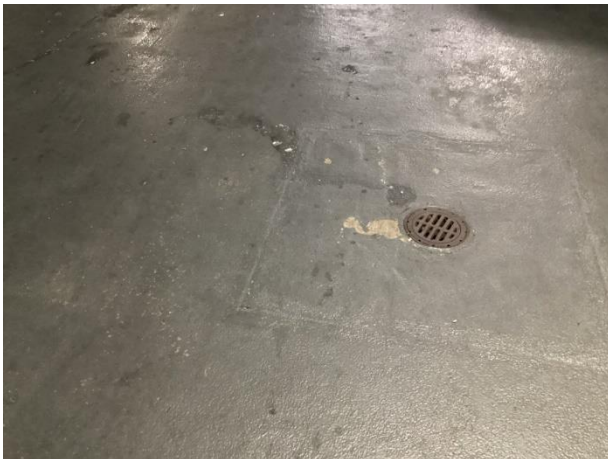
The traffic coating exhibits isolated areas of deterioration/damage, primarily at ramps and drive lanes. The Association will conduct limited traffic coating repairs through the warranty in 2024.

Traffic coating damage

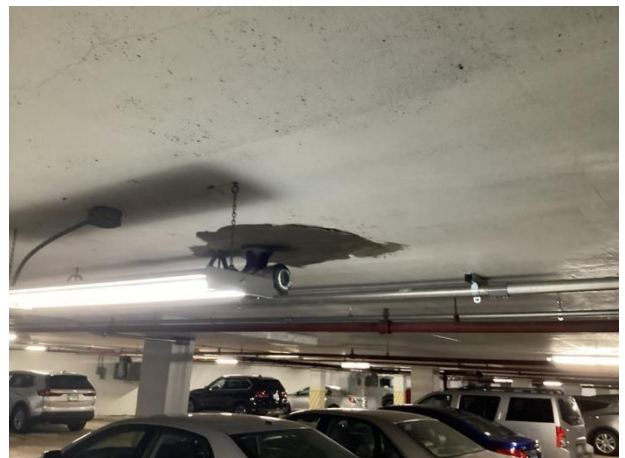
Typical repairs beneath elevated floor

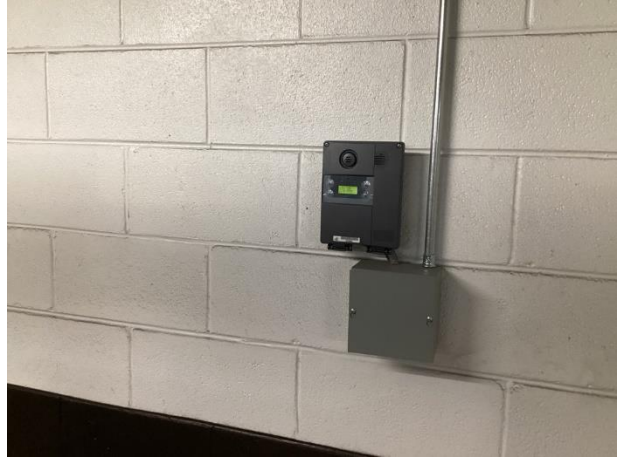
Carbon monoxide detector

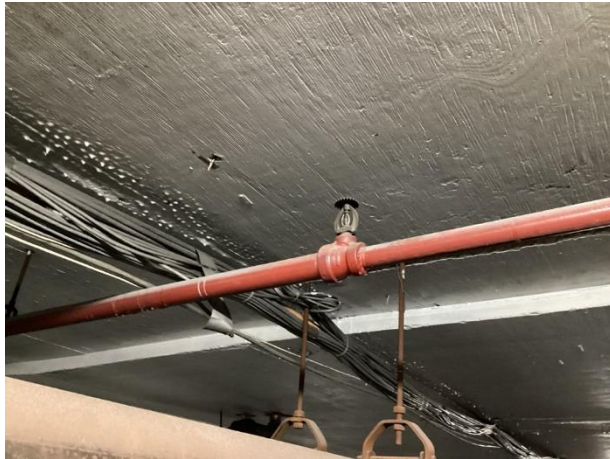
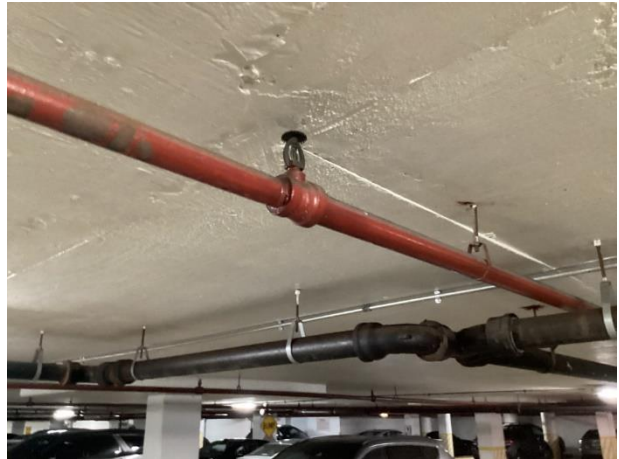
Condition: The piping systems are reported to be in satisfactory condition.

The Building Engineer informs us of the need to replace the heads in the near term. We therefore continue to include an allowance in the near term to replace the heads.

Fire suppression system at head

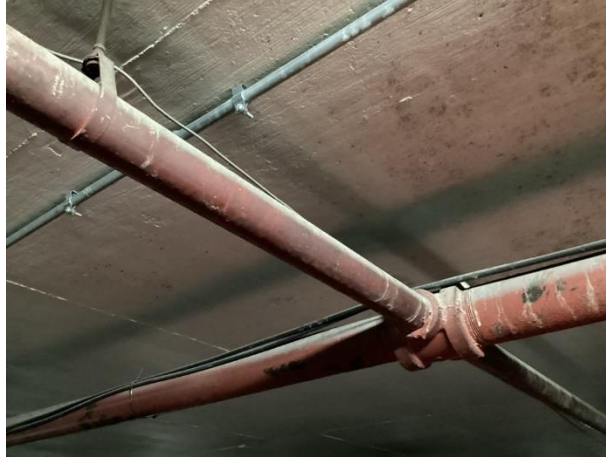
Fire suppression system at main and branch pipes

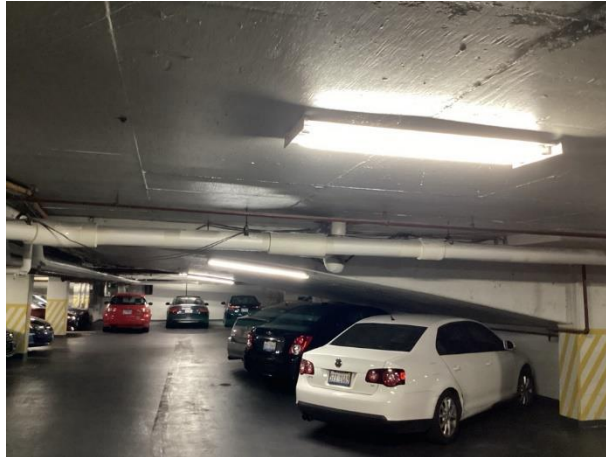
Condition: Reported satisfactory

Garage light fixtures

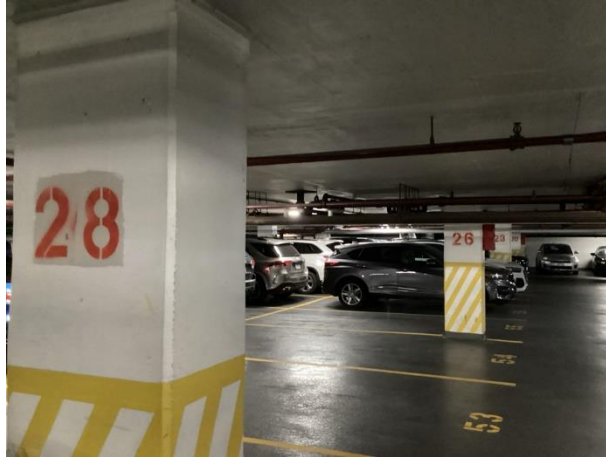
Condition: Conditions vary with areas of scuffs and stains evident

Garage paint finishes overview

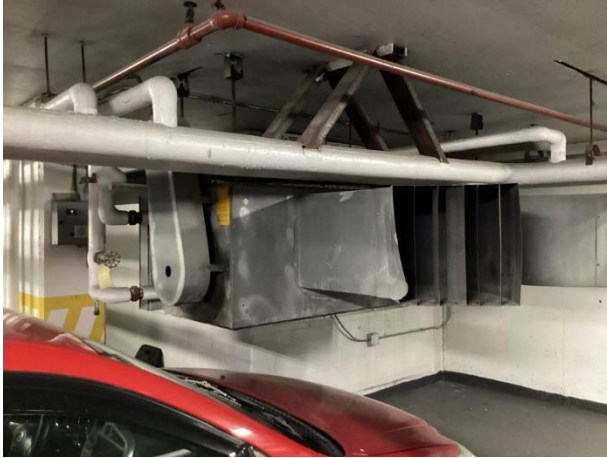
Condition: Reported satisfactory overall. The Building Engineer informs us of a history of use of parts from air handling units to repair other units.

Garage air handling unit

We continue to include an allowance in the near term to replace the original units. We also include a subsequent expenditure to replace the units installed in 2019.

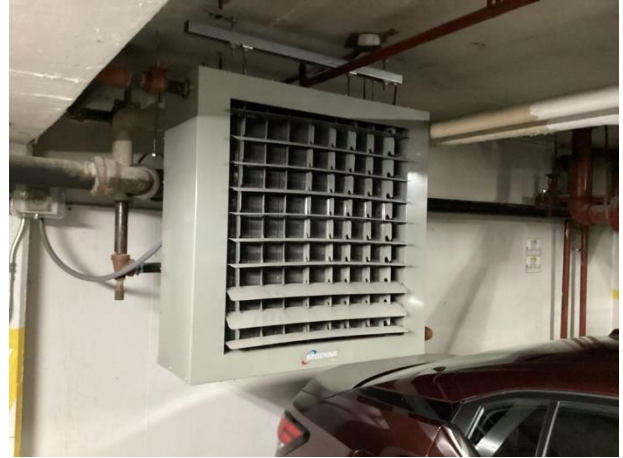
Garage unit heater
