Park Tower Condominium Association

June 19, 2024 • Chicago, IL

Park Tower Condominium Association
Chicago, Illinois

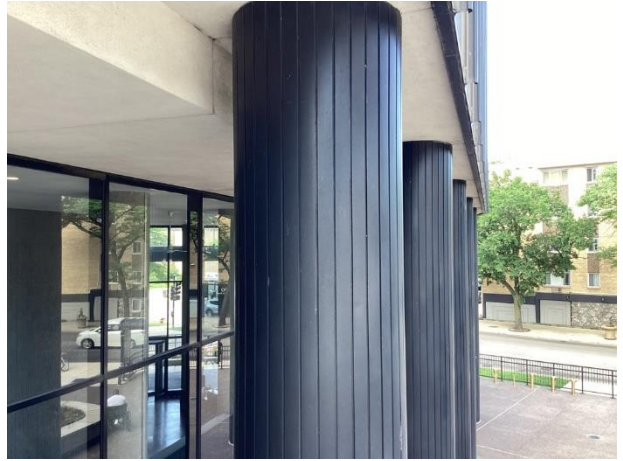
Column cladding

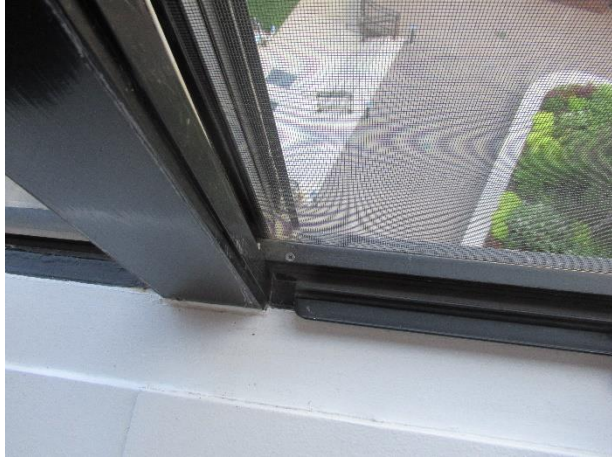
Management continues to inform us of limited water infiltration from the curtain wall system, primarily at operable windowsills. The Association replaces weather stripping at operable windows to remediate the water infiltration. We continue to include periodic expenditures for inspections and water infiltration remediation prior to extensive curtain wall system restorations. We partially base the expenditures on information provided by Management, including an increased cost in 2027 for an extensive evaluation of the conditions of the sealants.

Curtain wall at operable window

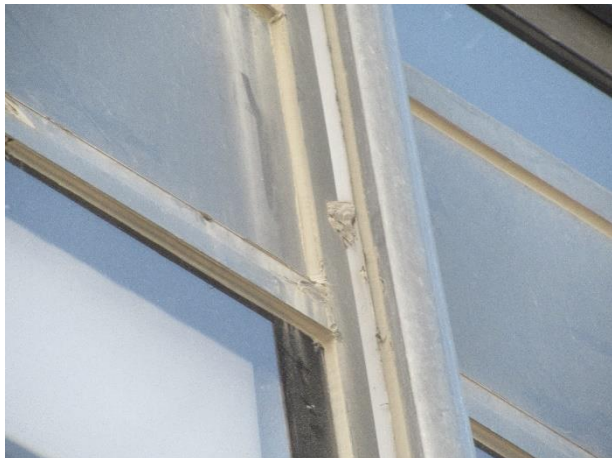
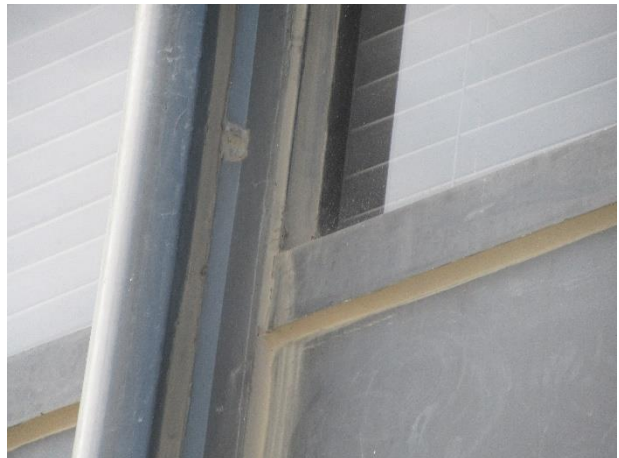
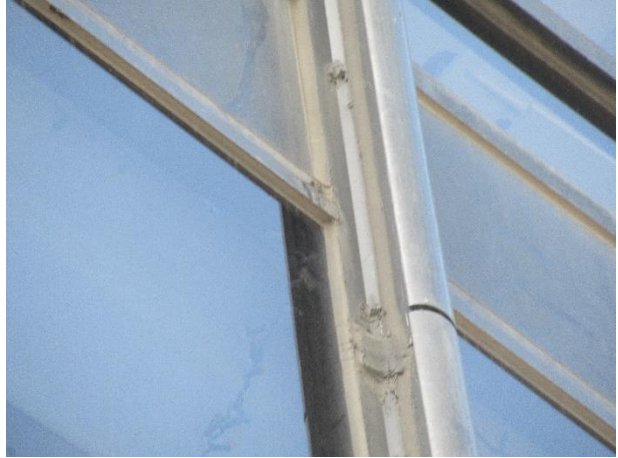
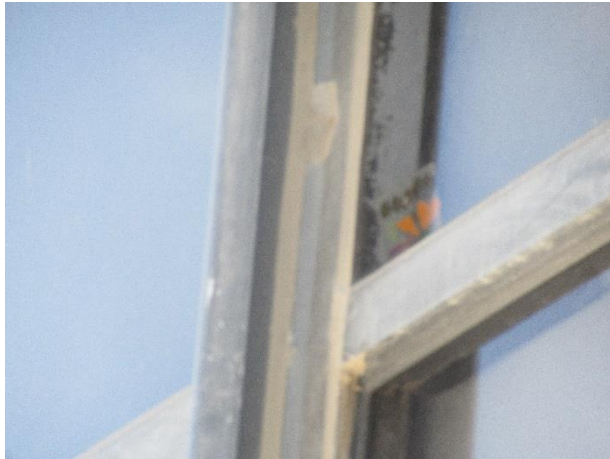
The curtain wall system exhibits isolated areas of exterior sealant deterioration. The weather stripping at unit interiors varies greatly in condition.

Glass/metal and metal/metal sealants

- Complete inspection of the curtain wall
- Replacement of eighty percent (80%) of the sealants
- Replacement of a limited amount of glazings
- Invasive inspection of a limited amount of anchors and refastening of aluminum components as needed
- Cleaning of the spandrel panels
- Touch-up finish applications
- Sidewalk protection
- Engineering allowance

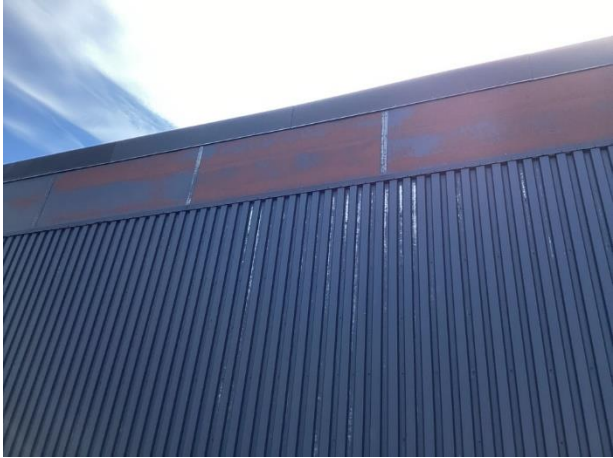
The siding is in fair overall condition. Areas of finish damage/deterioration are evident. The finish coloration varies. The Building Engineer informs us that the Association may paint select locations in the near term.

Siding color variations

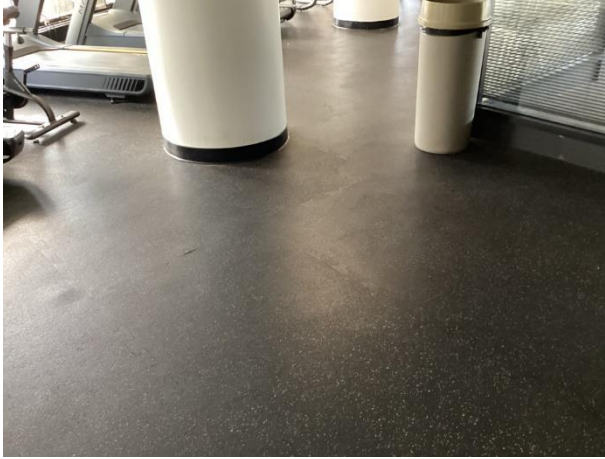
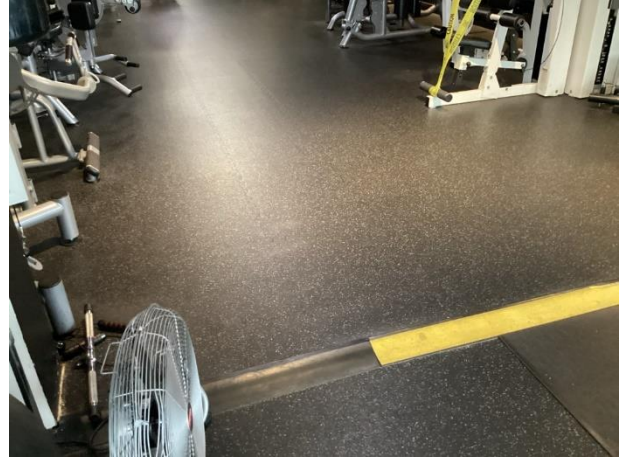
Condition: Fair overall with ceiling and flooring system damage evident

Cardio room finishes

Weight room finishes

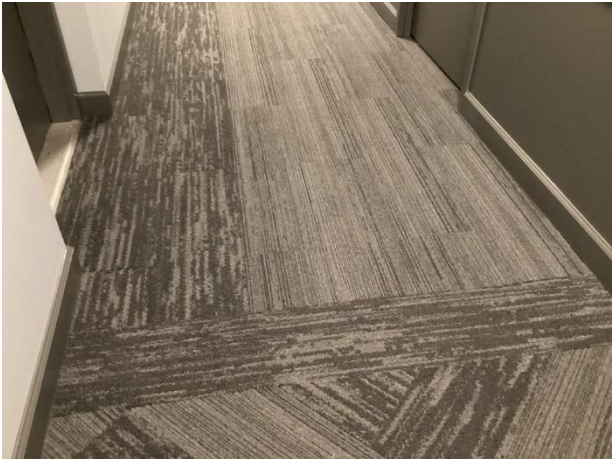
Condition: The replaced carpet is in good overall condition.

Recently installed carpet

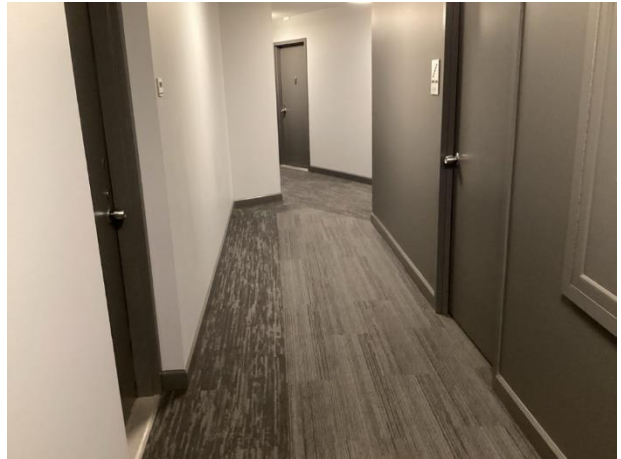
Renovated hallway

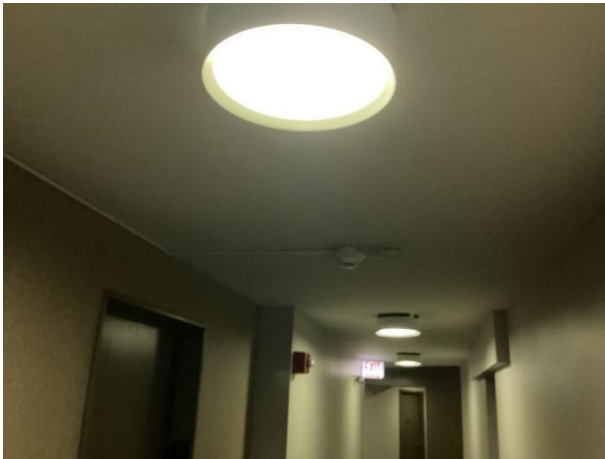
Dated fixtures

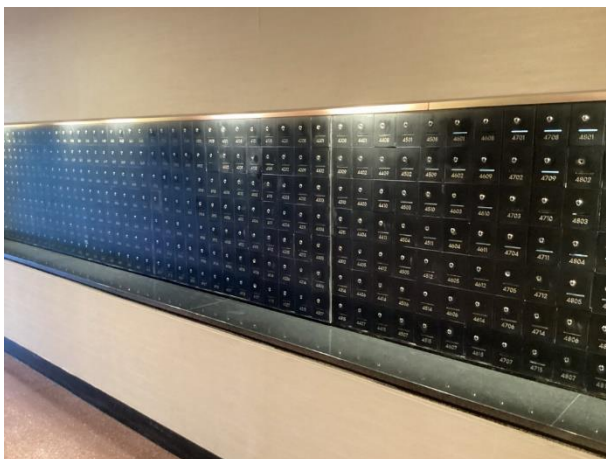
Condition: The mailboxes have limited capacities. The Building Engineer informs us of a limited recent history of issues.

Mailboxes

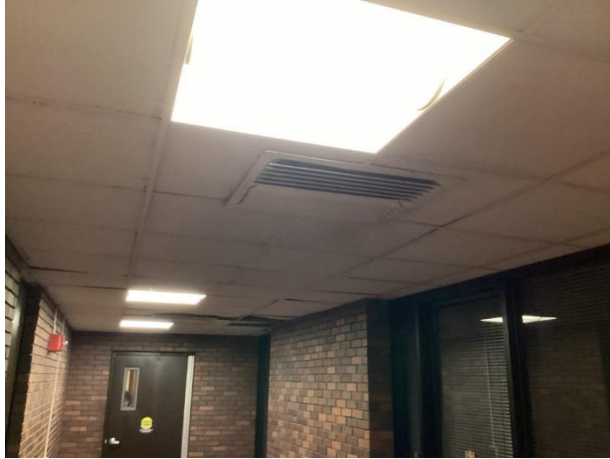
- **Corridors** – 5,500 square feet of terrazzo floor and ceiling tile system with light fixtures, the ceiling tile system exhibits areas of stains/damage, the Association replaced the runners in 2023, we continue to include an allowance in the near term to replace the furnishings
- **Market (Store)** – concrete floor, ceiling tile system, light fixtures and paint finishes, the Association removed the floor coverings in 2016, the ceiling tile system exhibits areas of stains/damage
- **Office** – systematic renovation in 2012, carpet replacement and paint application completed in 2022

Mall ceiling tile stains

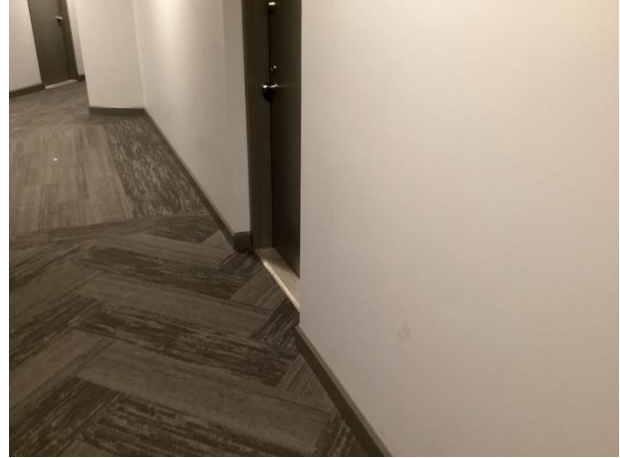
Wall scuffs

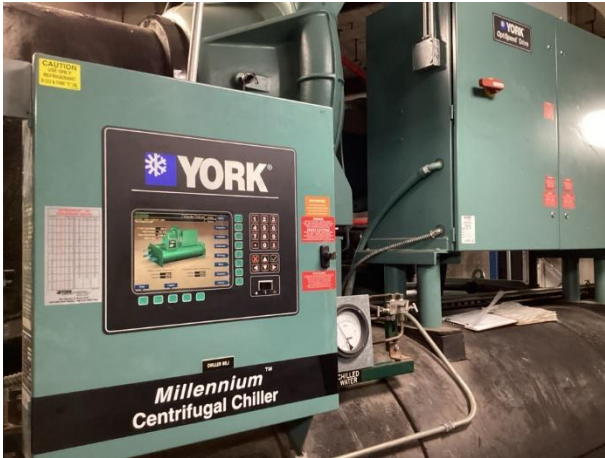
Condition: Reported satisfactory without operational deficiencies

We include near term Management provided expenditures for chiller tear down inspections. We slightly increase the unit cost to include an allowance for limited repairs identified during the inspection.

Chiller

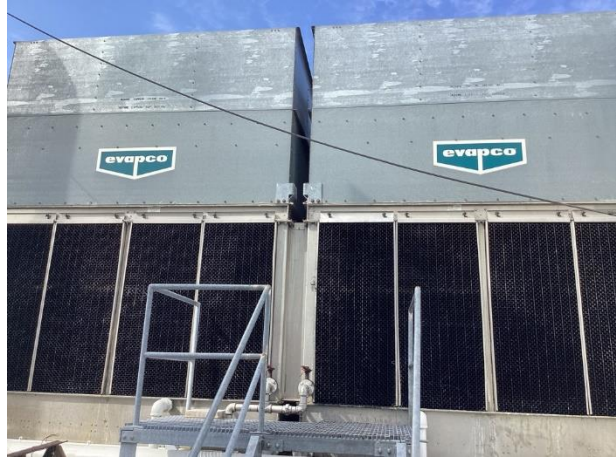
Cooling towers

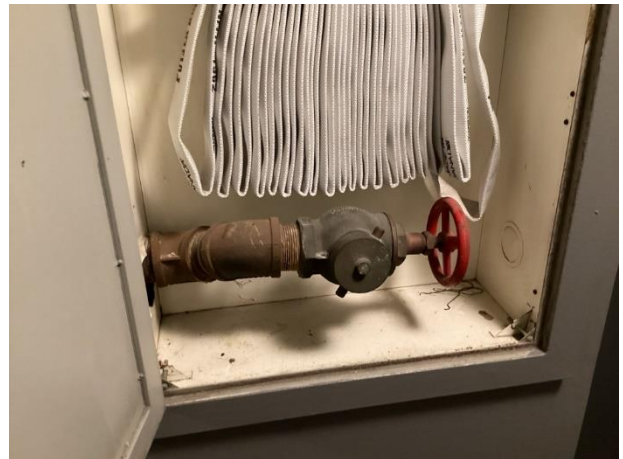
The Building Engineer informs us of the need to replace the 104 valves for the fire standpipes. We include a cost provided by the Building Engineer in the near term.

Valve for standpipe

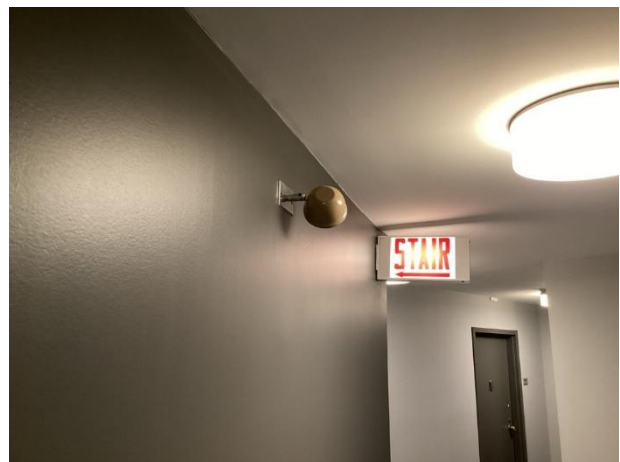
Condition: Reported satisfactory overall (Management informs us that the Association will likely replace the remaining dated fixtures upon completion of the hallway renovation project.)

Fixtures at hallway

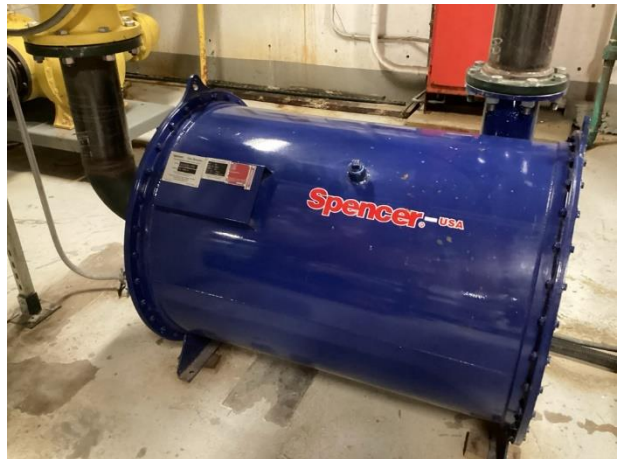
- **Gas Booster** - 10-HP, two each, one pump replaced in 2021 and one pump replaced in 2024, include variable frequency drives, reported satisfactory
- **Sewage Ejection** - 10-HP, two each, replaced 2018, reported satisfactory

Gas booster pump

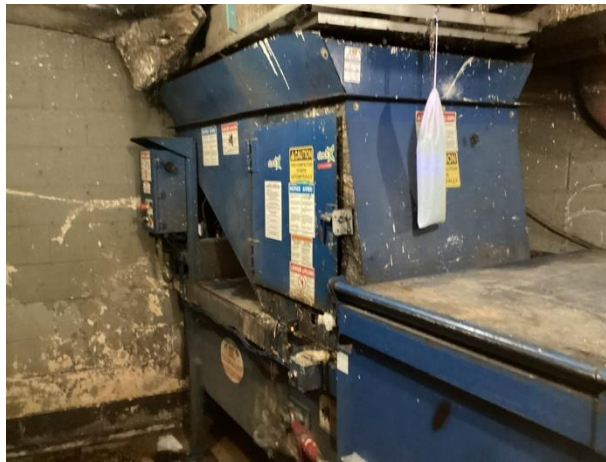
Condition: Reported satisfactory without operational deficiencies

Trash compactor

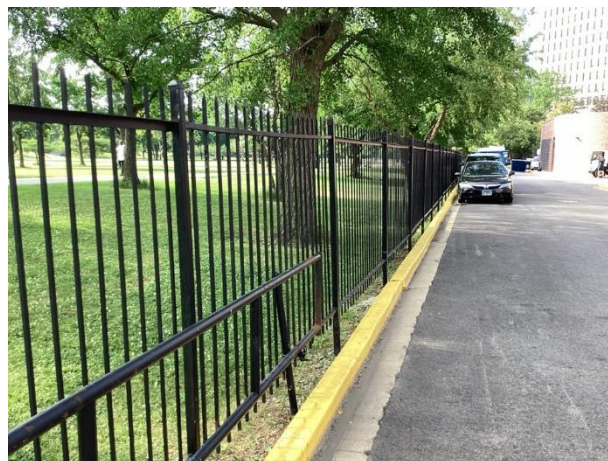
Quantity and Condition: The east perimeter includes a steel fence. We include a Management provided expenditure to replace this fence in the near term based on its condition.

East perimeter fence

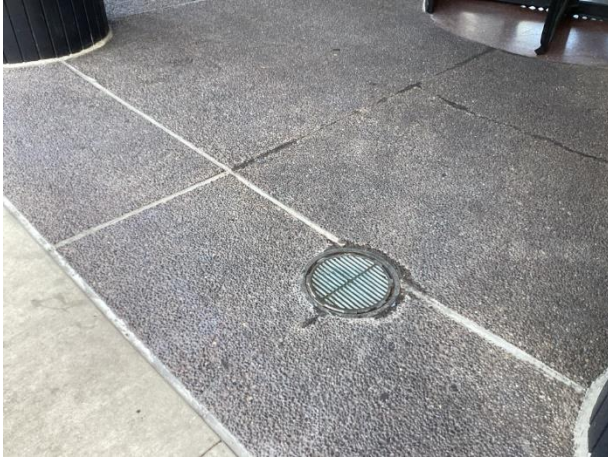
Condition: The concrete toppings exhibit areas of cracks and joint sealant deterioration. The concrete walls at the planters exhibit cracks. The ceiling beneath the plaza exhibits isolated evidence of water infiltration and a significant amount of previous repairs.

Concrete joints

- Replacement of sealants
- Crack repairs as needed
- Replacement of a limited amount of concrete topping
- Replacement of a limited amount of membrane (leak remediation)

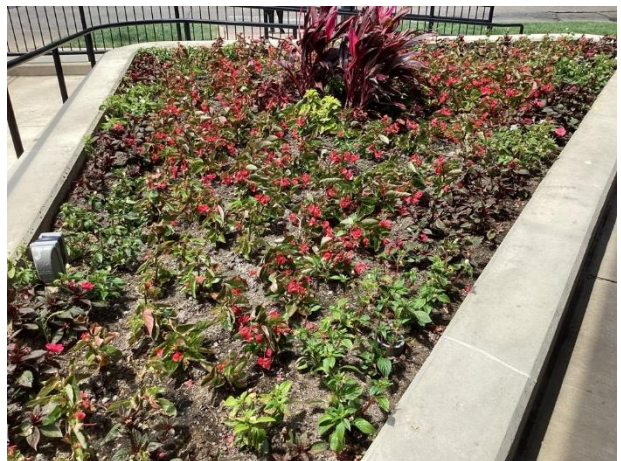
Lobby entrance planter

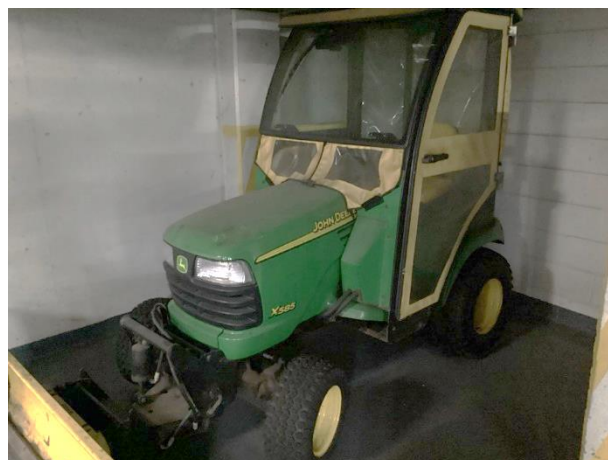
History: We continue to include a cost to replace the tractor in the near term. The exact cost will vary based on the model of tractor purchased.

Tractor

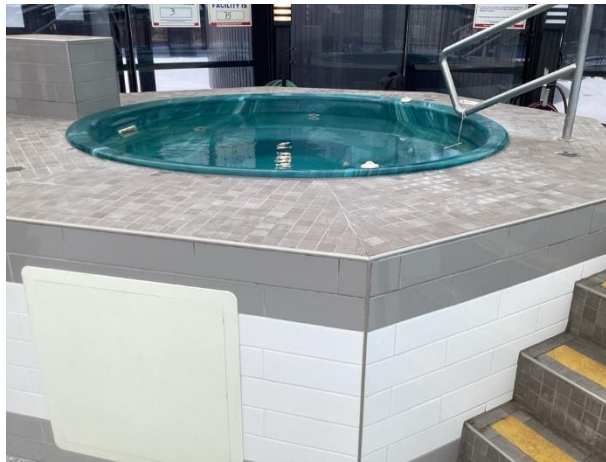
Condition: The hot tub insert is in reported satisfactory condition.

Hot tub

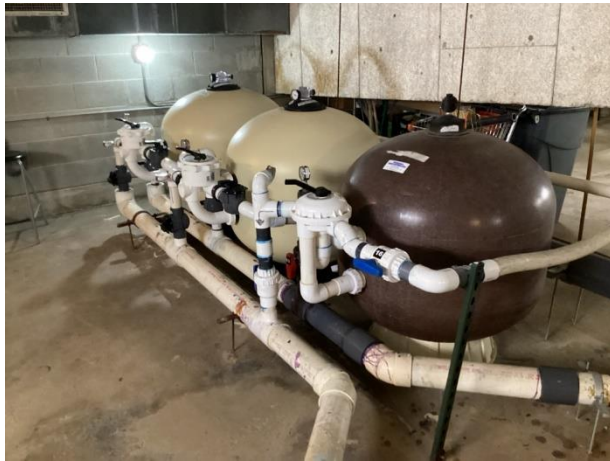
Condition: Conditions vary. The equipment is in reported overall satisfactory condition with the exception of leakage at the drainage basin. The Building Engineer informs us that the Association will likely install a liner in the basin.

Pool filters

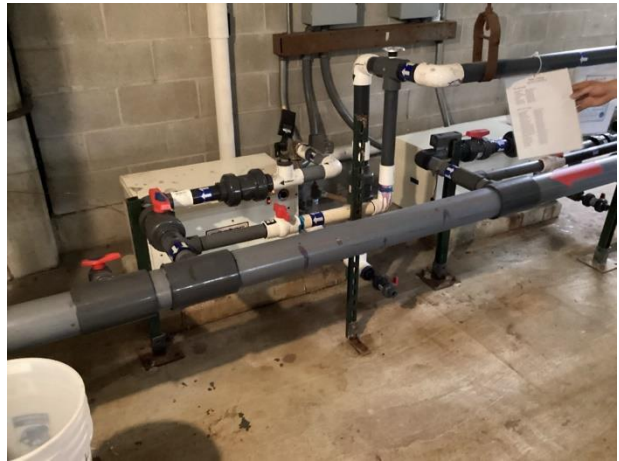
Pool heaters

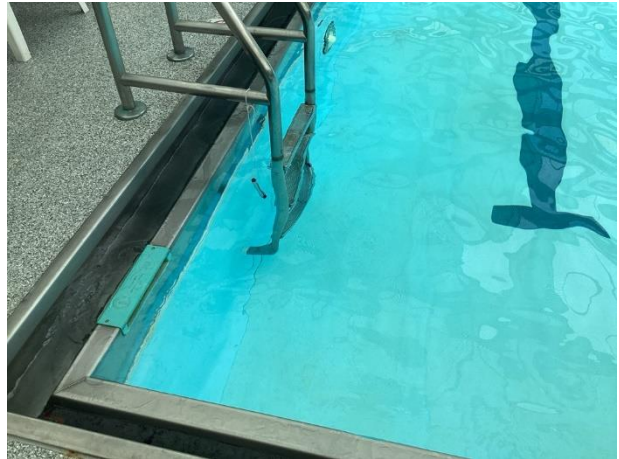
Pool at liner

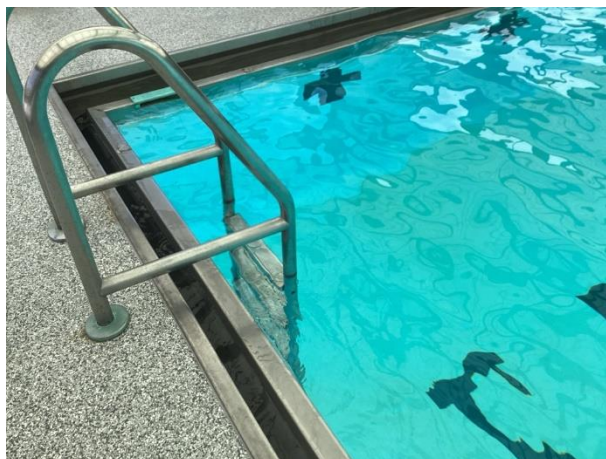
Pool at liner

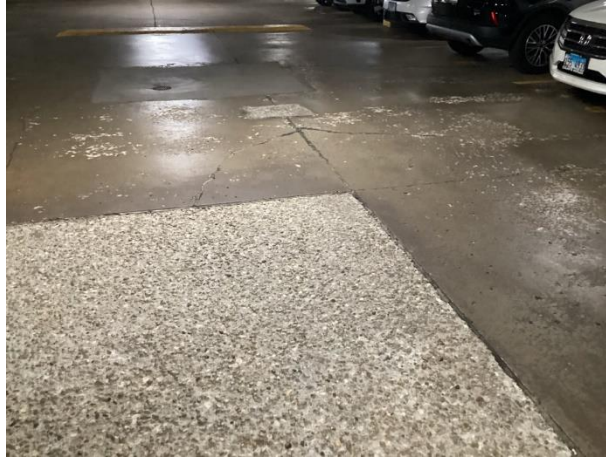
Condition: Conditions vary with areas of cracks, deterioration of original and repaired concrete, and surface spall evident.

Concrete spall

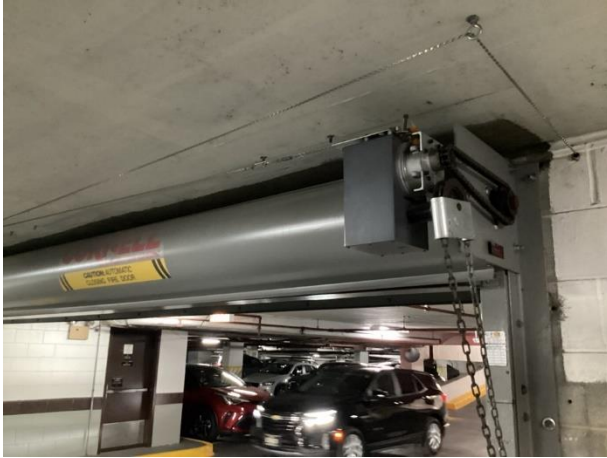
Condition: The vehicular and fire doors are in reported satisfactory condition.

Fire door

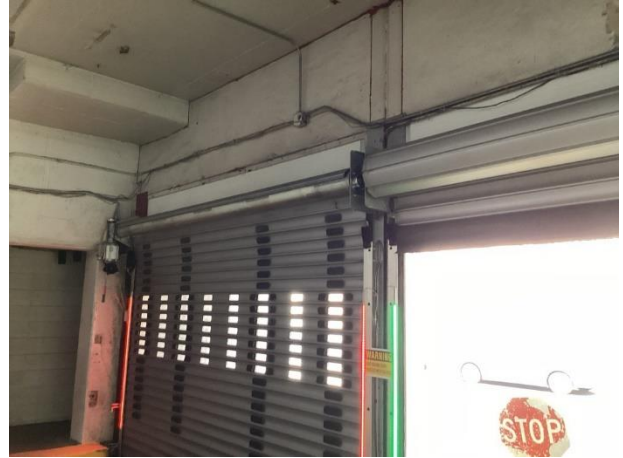
Vehicular doors

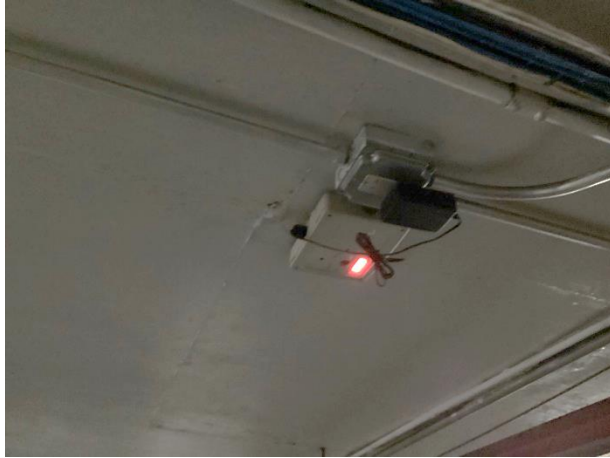
Carbon monoxide detector

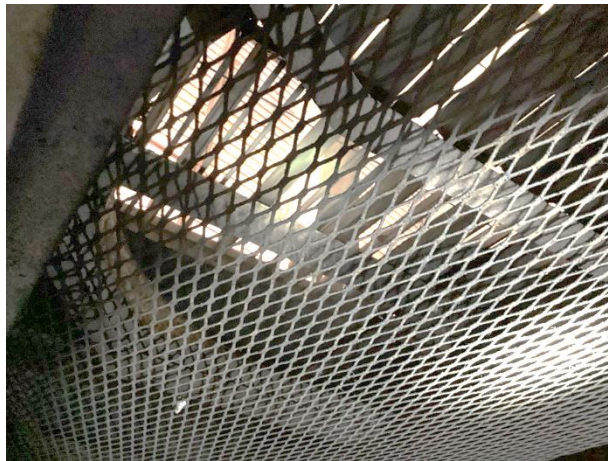
Condition: The fans are in reported satisfactory condition.

Carbon monoxide detector
